**Federal Aviation  
Administration**

Merced Regional/Macready Field  
Merced California  
Letter of Correction

The periodic certification inspection of the Merced Regional/Macready Field (MCE) was conducted 17-19 Nov 2014. The inspection revealed that the airport is not being operated in compliance with 14 CFR Part 139, the Airport Certification Manual (ACM), and the Airport Operating Certificate.

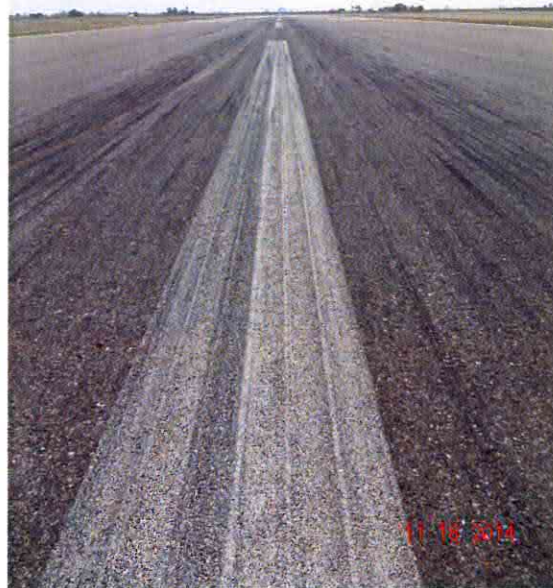
**§139.311(a)(1) – Runway Markings.** The certificate holder failed to maintain runway markings. Runway 12-30 centerline markings were found badly faded. Runway designation and threshold markings exhibited both white and beige hues. Where the threshold markings width was decreased, remnants of the white paint is still visible during daytime and hours of darkness. Also, in some areas of the markings, the paint appeared to be missing beads. The certificate holder must ensure all runway markings meets the standards outlined in AC 150/5340-1, *Standards for Airport Markings*, current edition. Pavement markings that are no longer needed are not to be painted over but instead are to be physically removed. Physical removal of markings is achieved by water blasting, shot blasting, sand blasting, chemical removal, or other acceptable means that do not harm the pavement. The physical removal of any old marking(s) must include a pre-determined larger size and shape of a removal area that encompasses the old marking(s) and by grouping adjacent markings together into a larger rectangular removal area.

Faded Runway Centerline

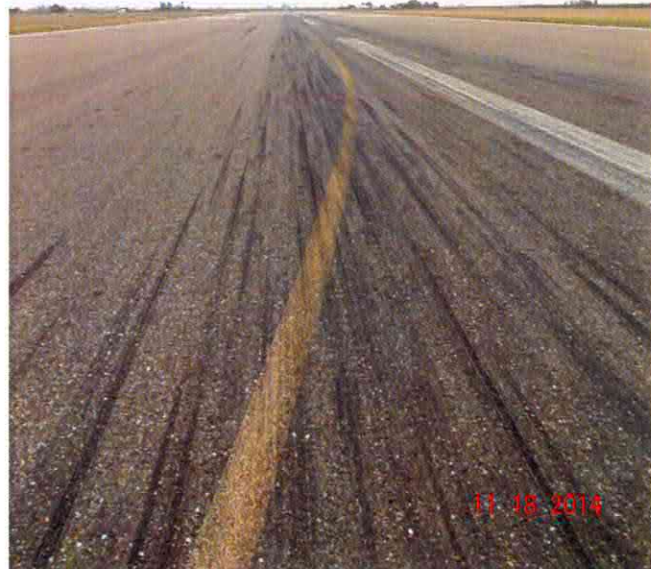
**§139.311(a)(2) – Taxiway Markings.** The certificate holder failed to maintain taxiway centerline markings. Taxiway centerlines were found badly faded. Additionally, not all lead-on/off lines that lead to the runway were visible. The certificate holder must ensure all taxiway markings meets the standards outlined in AC 150/5340-1, *Standards for Airport Markings*, current edition.

Faded Lead on/off line
