# Applegate Park

## Laura's Fountain Update

# Laura's Fountain

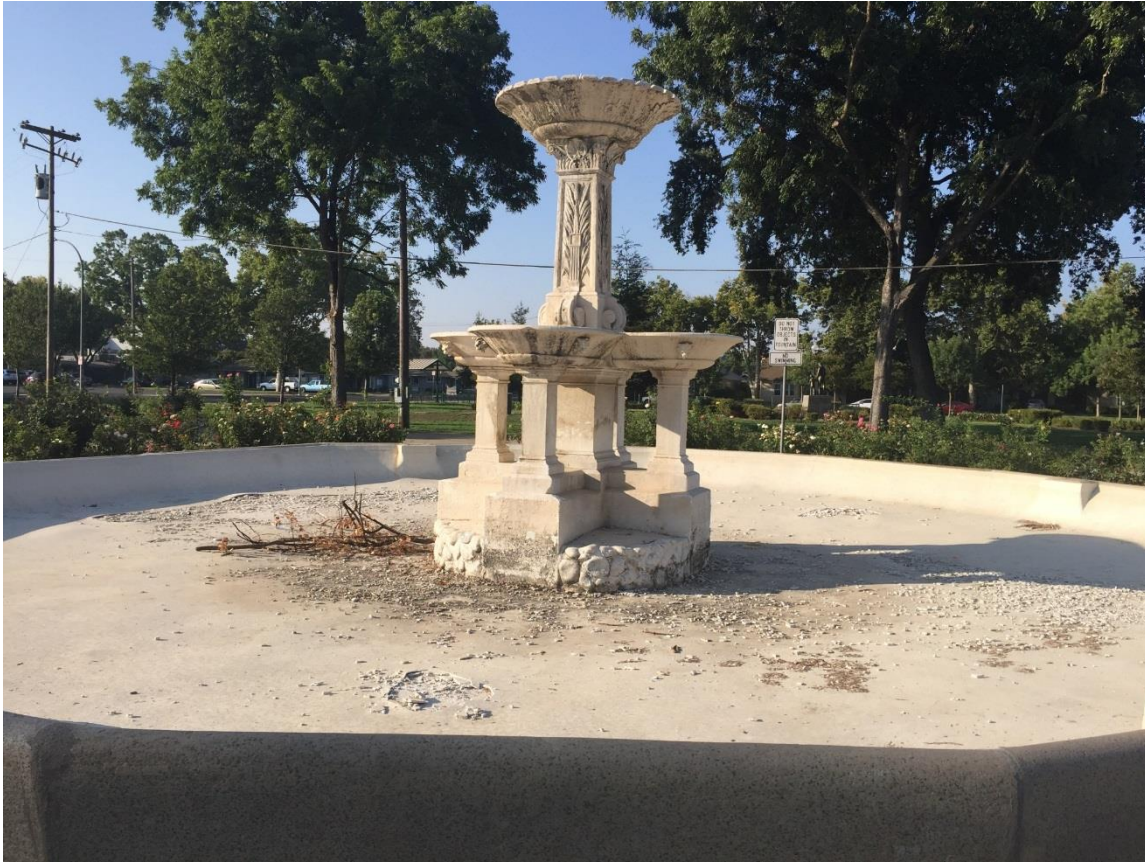
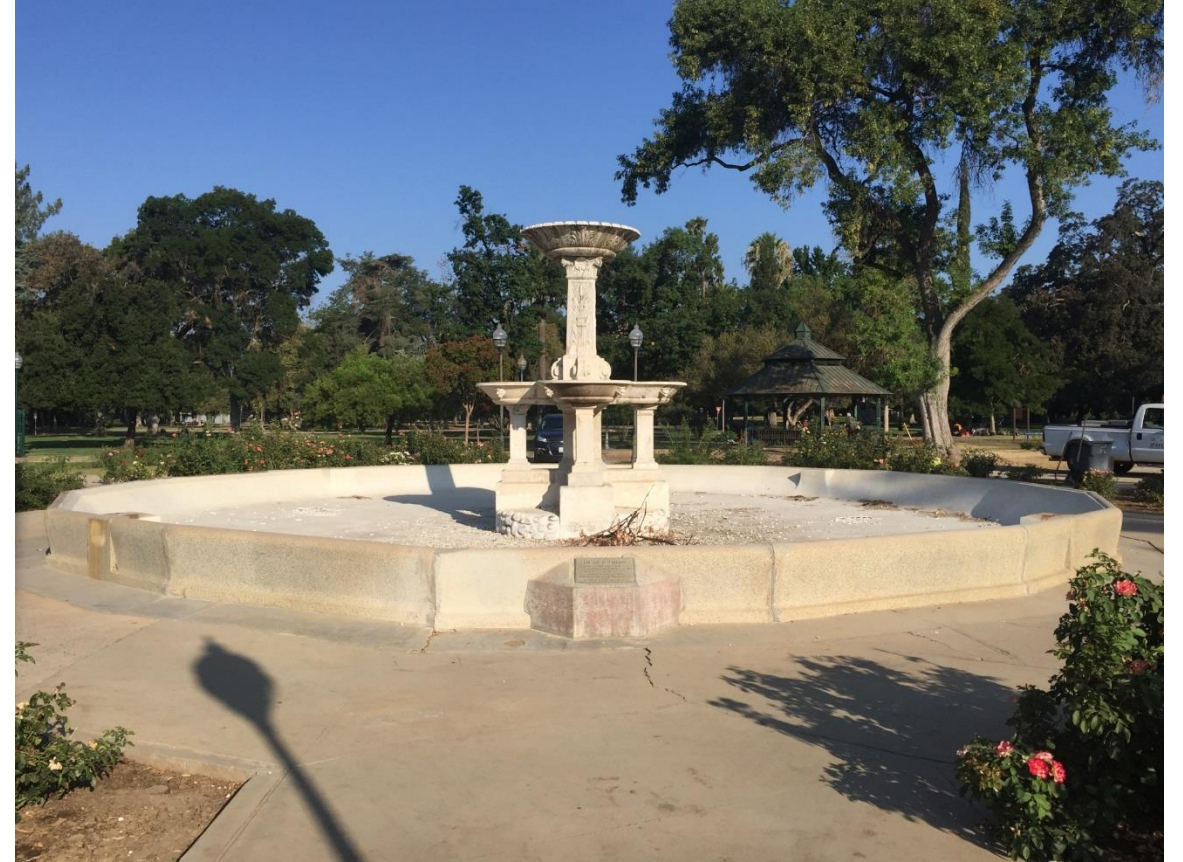
# Laura's Fountain – Existing Condition

- Concrete Slab around Fountain – no reinforcing steel found
- Subsurface Soil - Moderately expansive clay soil and saturated
- Shrink and swell cycles of clay soil – causing movement, settlement and unevenness
- Shrink and swell cycles beneath fountain will continue in the future – how much? - variable

- Mitigate future potential shrink and swell of uncompacted fill under fountain concrete
- Provide a stable subgrade for fountain and surrounding concrete
- Option 1 – Excavate and Recompact
  - Remove clayey soils and replace with non-expansive engineered fill
  - Minimum of 2 feet depth and placed in 8 inch horizontal lifts and compacted
- Option 2 – Grout Injection
  - Densification of subgrade by injection of cement or polyurethane grout
  - Remove and replace concrete slab around fountain

- It is assumed that the Fountain sits on a concrete slab most likely with no steel
- It is recommended that a new steel reinforced concrete slab on grade (4" to 5" thick)
- Recommend a continuous spread footings be utilized to support the fountain
- Footings minimum embedment depth of 18 inches below lowest adjacent grade
- Restore fountain

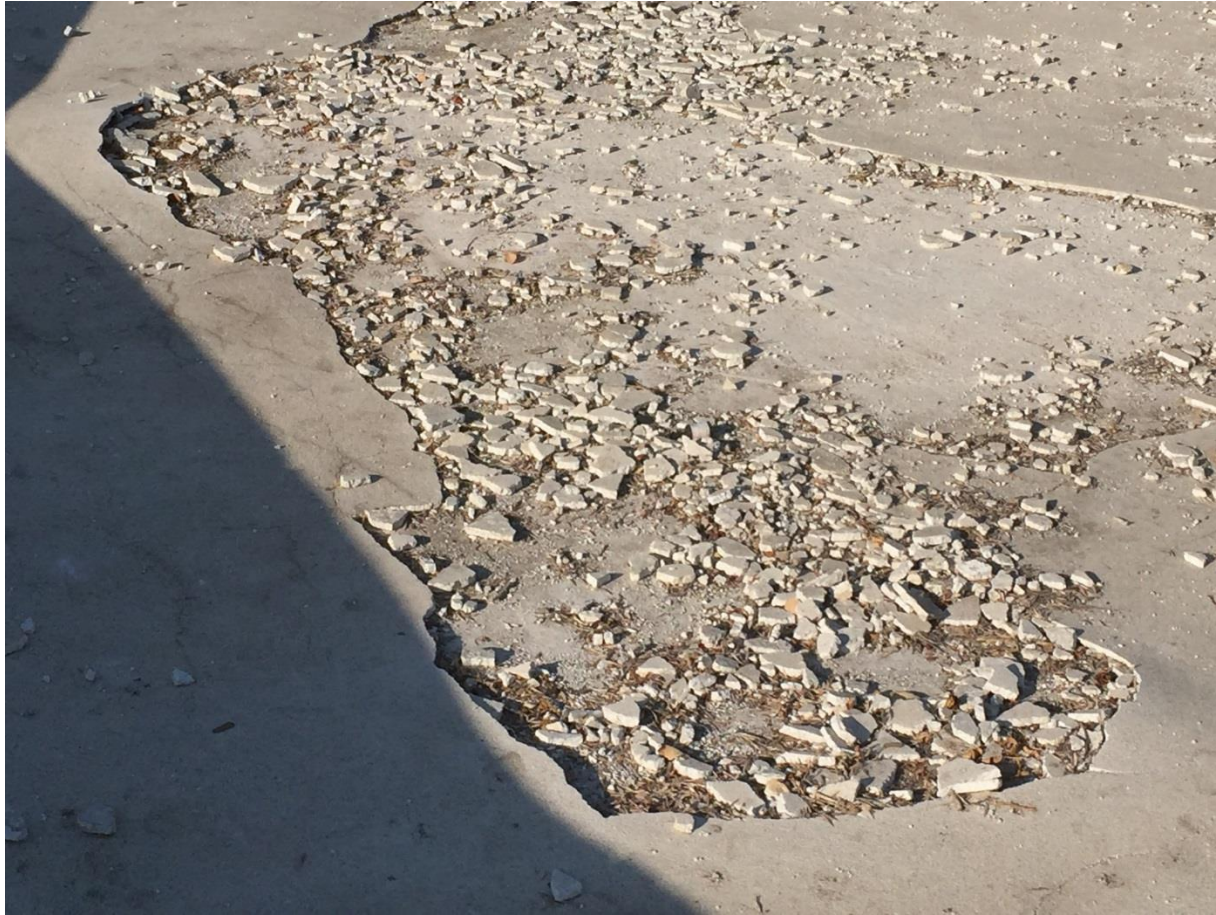
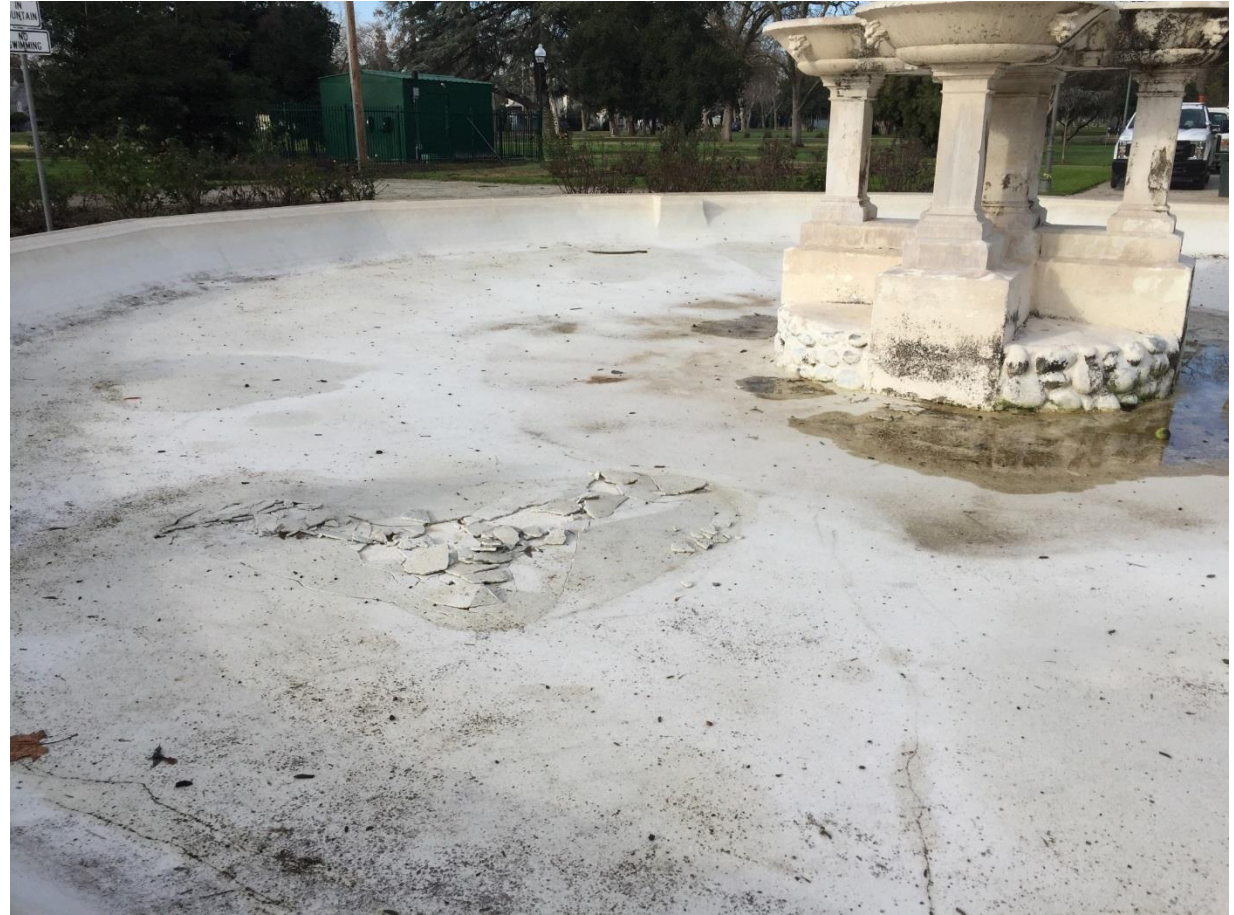
# Laura's Fountain – Existing Condition

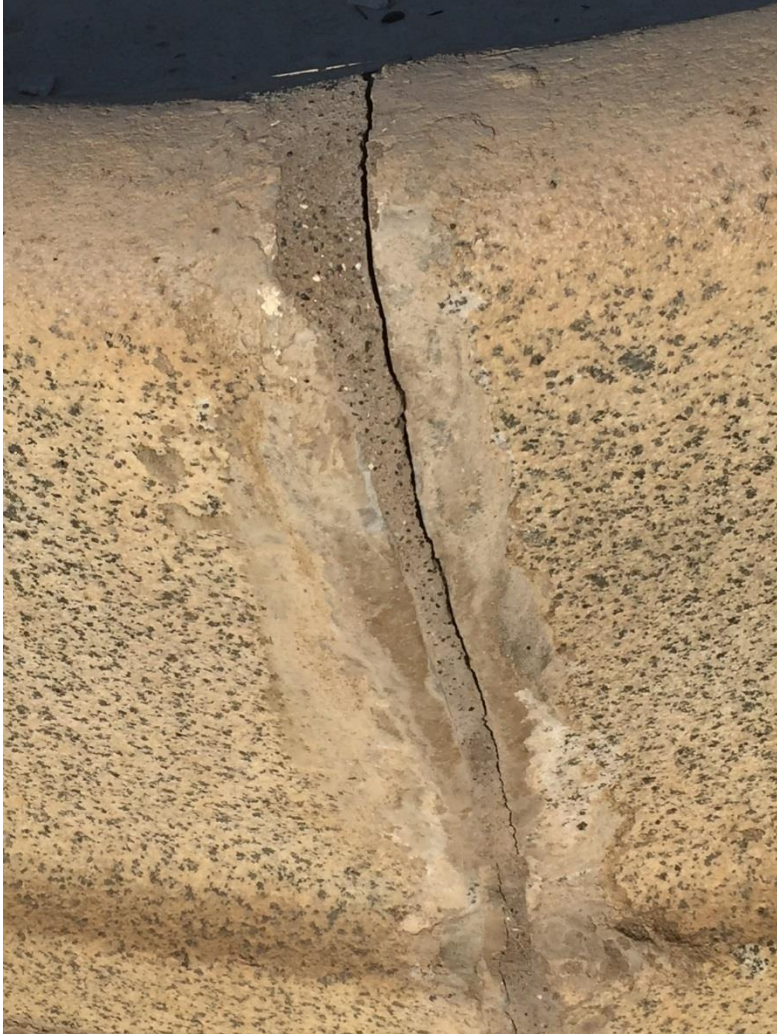
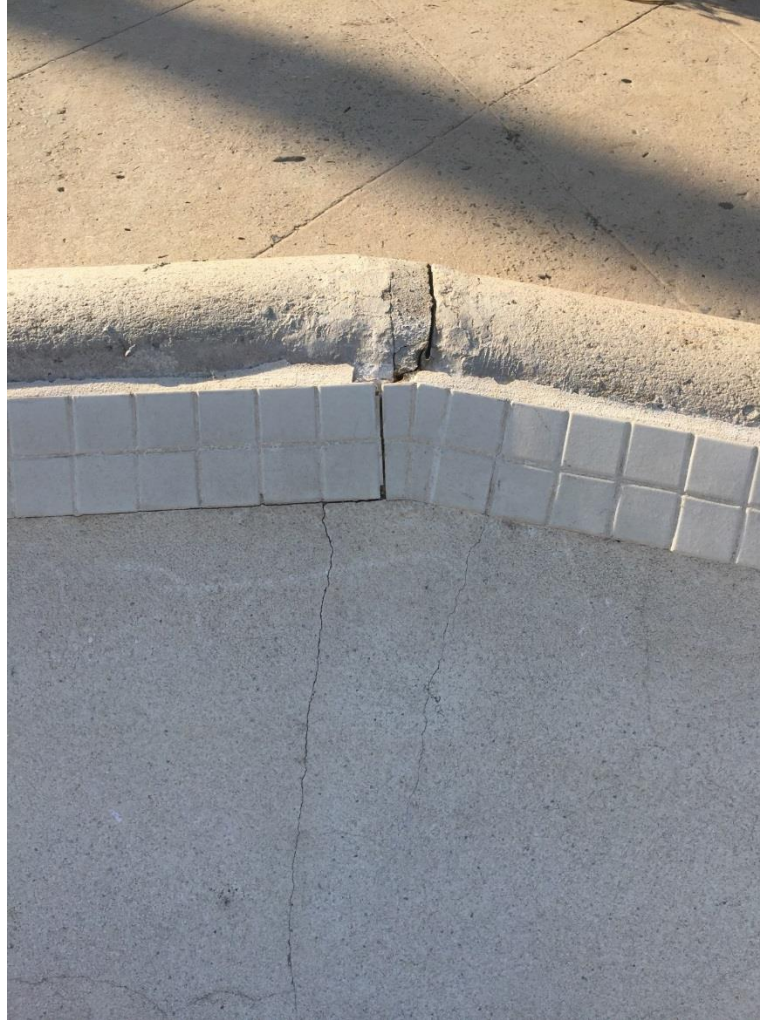
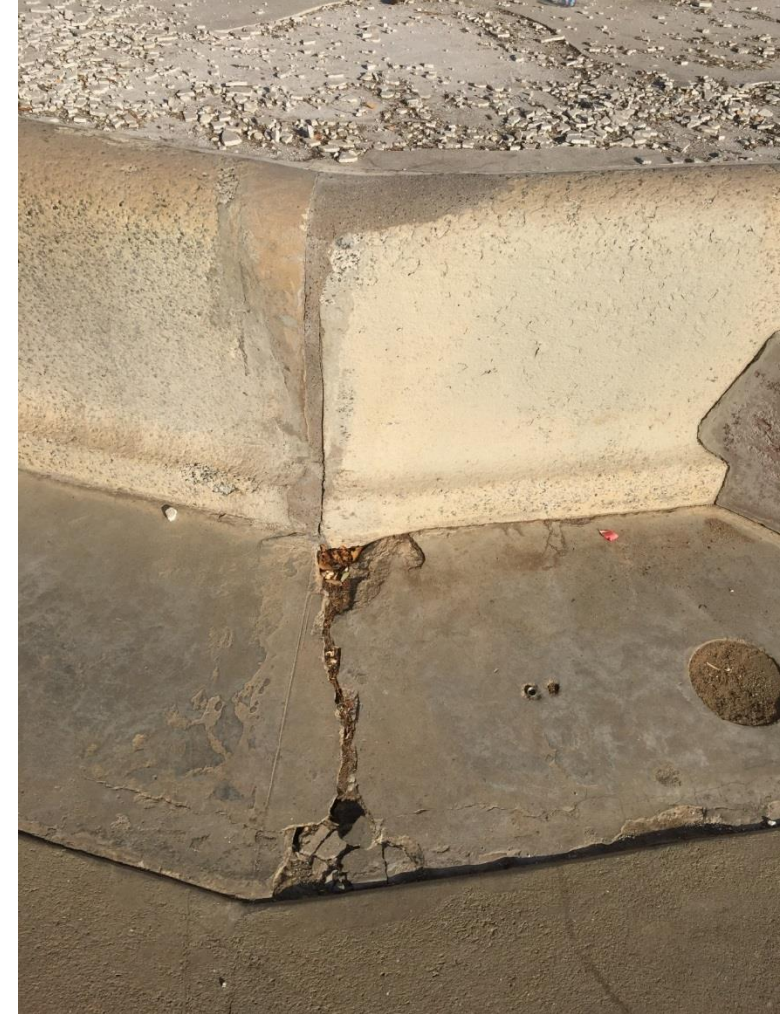
# Laura's Fountain – Existing Condition
