City of Merced CA

## Sun Star Building Evaluation

Prepared by  
WMB Architects

February 23, 2016

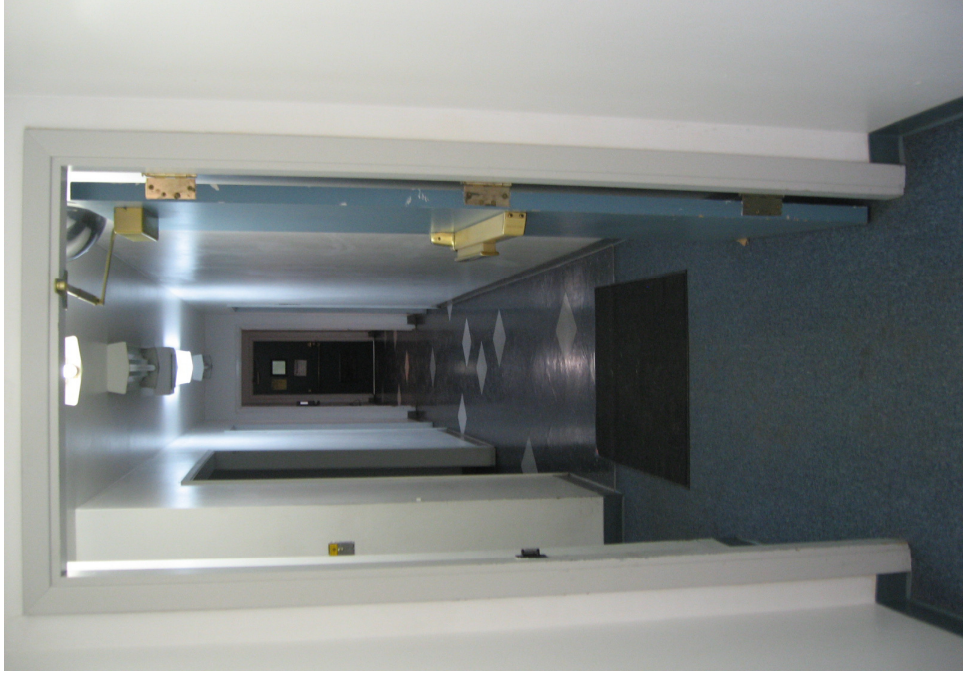
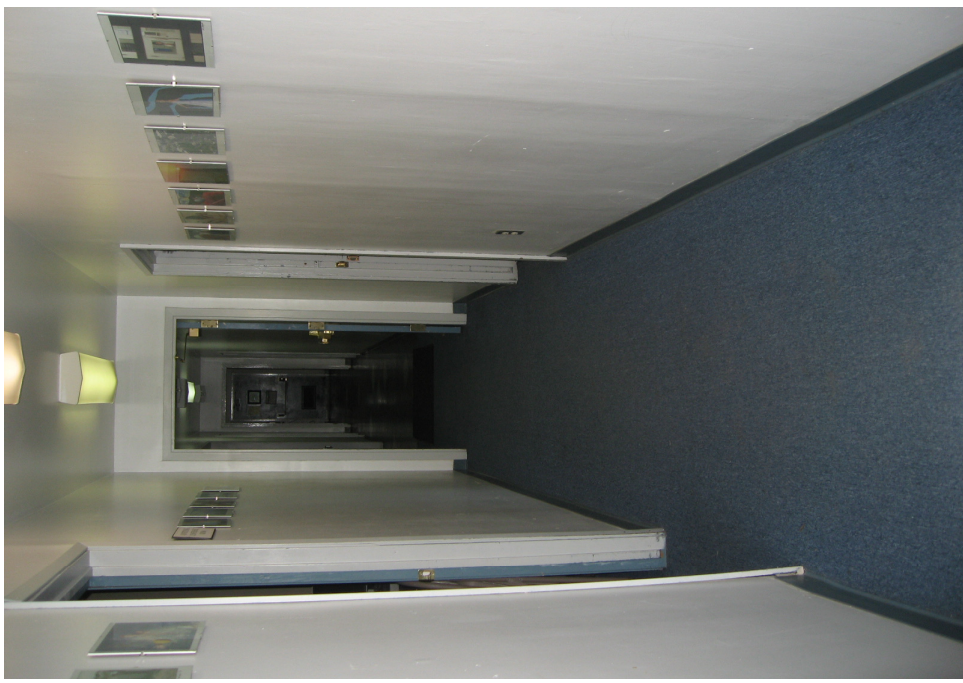
Interior doors without 18" push side clearance

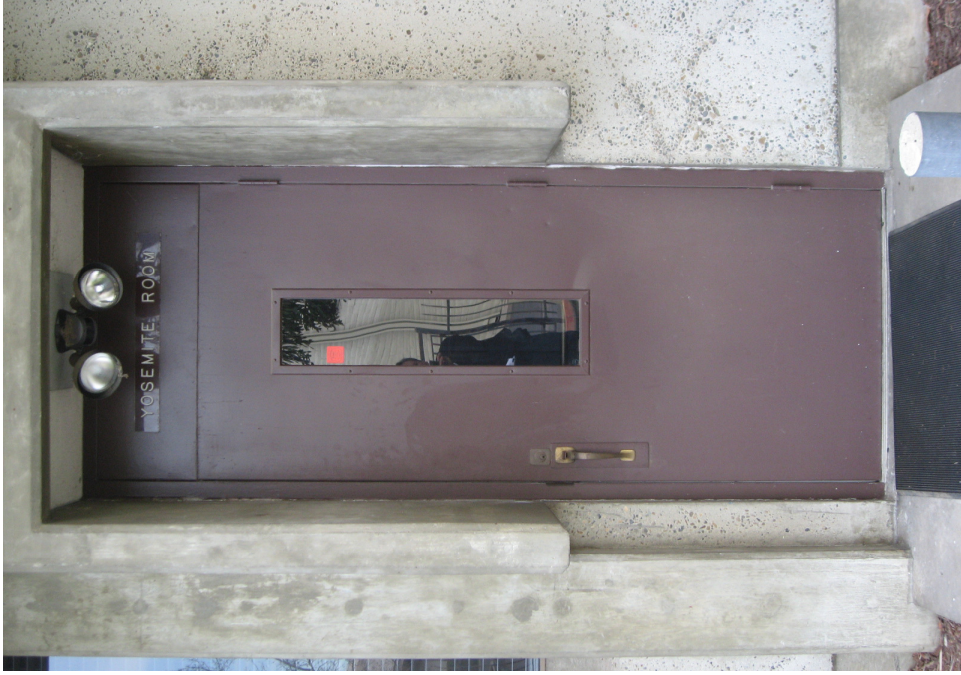
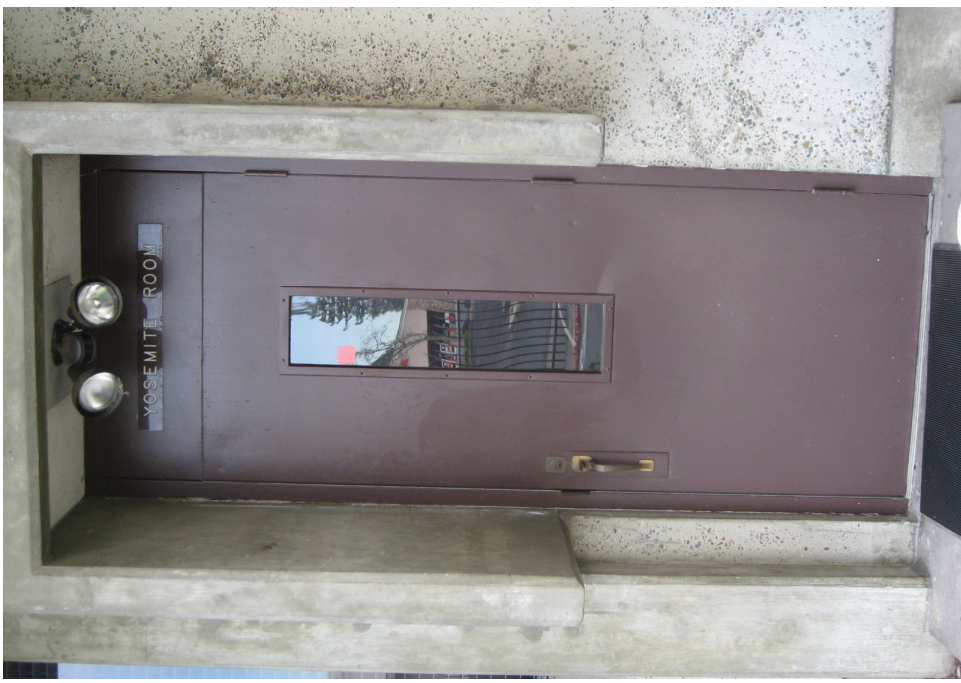
The exterior doors at A | 7 and G | 7 do not have the required 24" side clearance because of the concrete column at the door jamb which is greater than 8" in depth. The door and frame must be pulled-out to the face of the column (or replaced), and the interior gypsum wall patched and refinished. For purposes of this study and estimate, we assume the door re-used and relocated.

Exterior doors without 24" side clearance - concrete portico interference

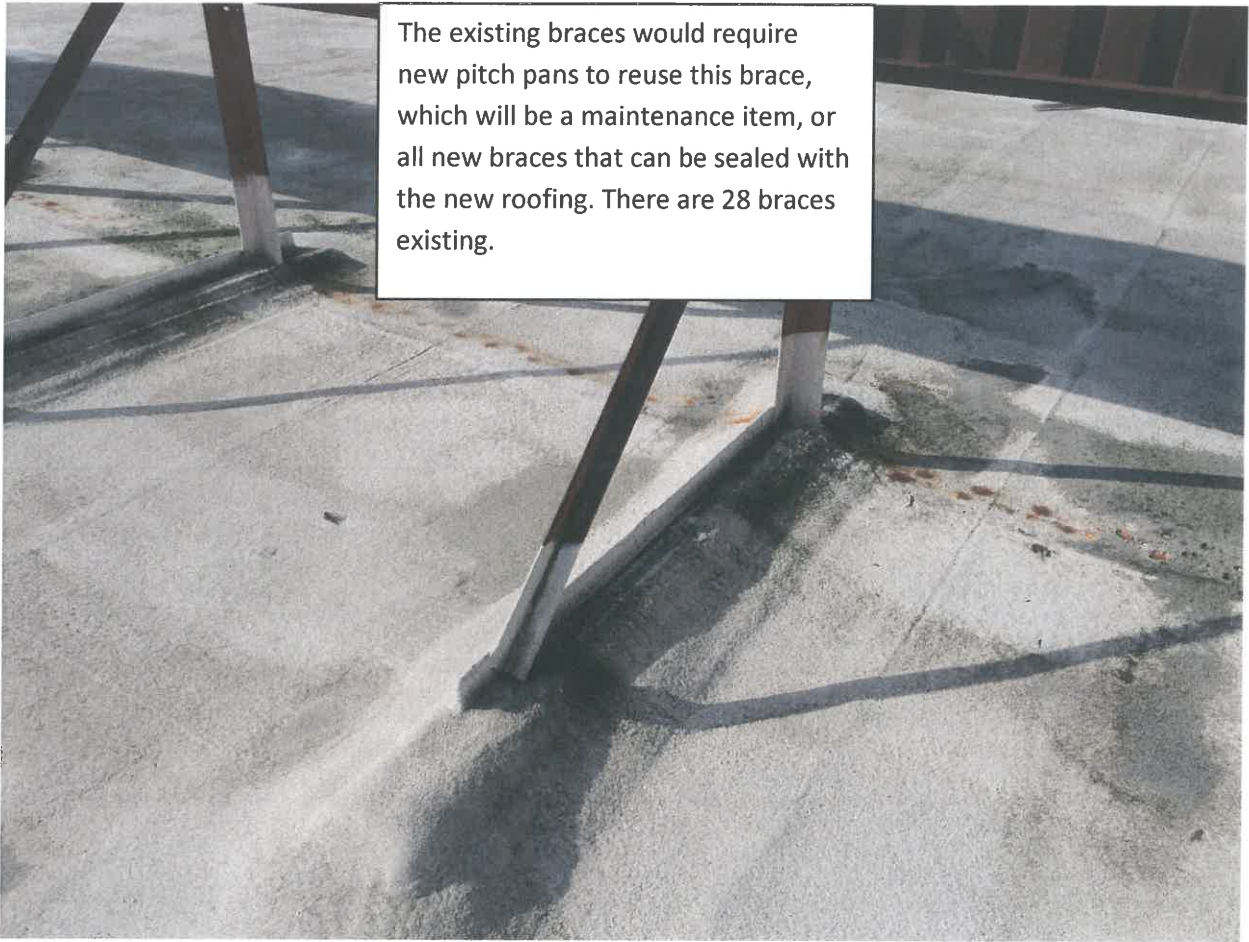
The existing braces would require new pitch pans to reuse this brace, which will be a maintenance item, or all new braces that can be sealed with the new roofing. There are 28 braces existing.

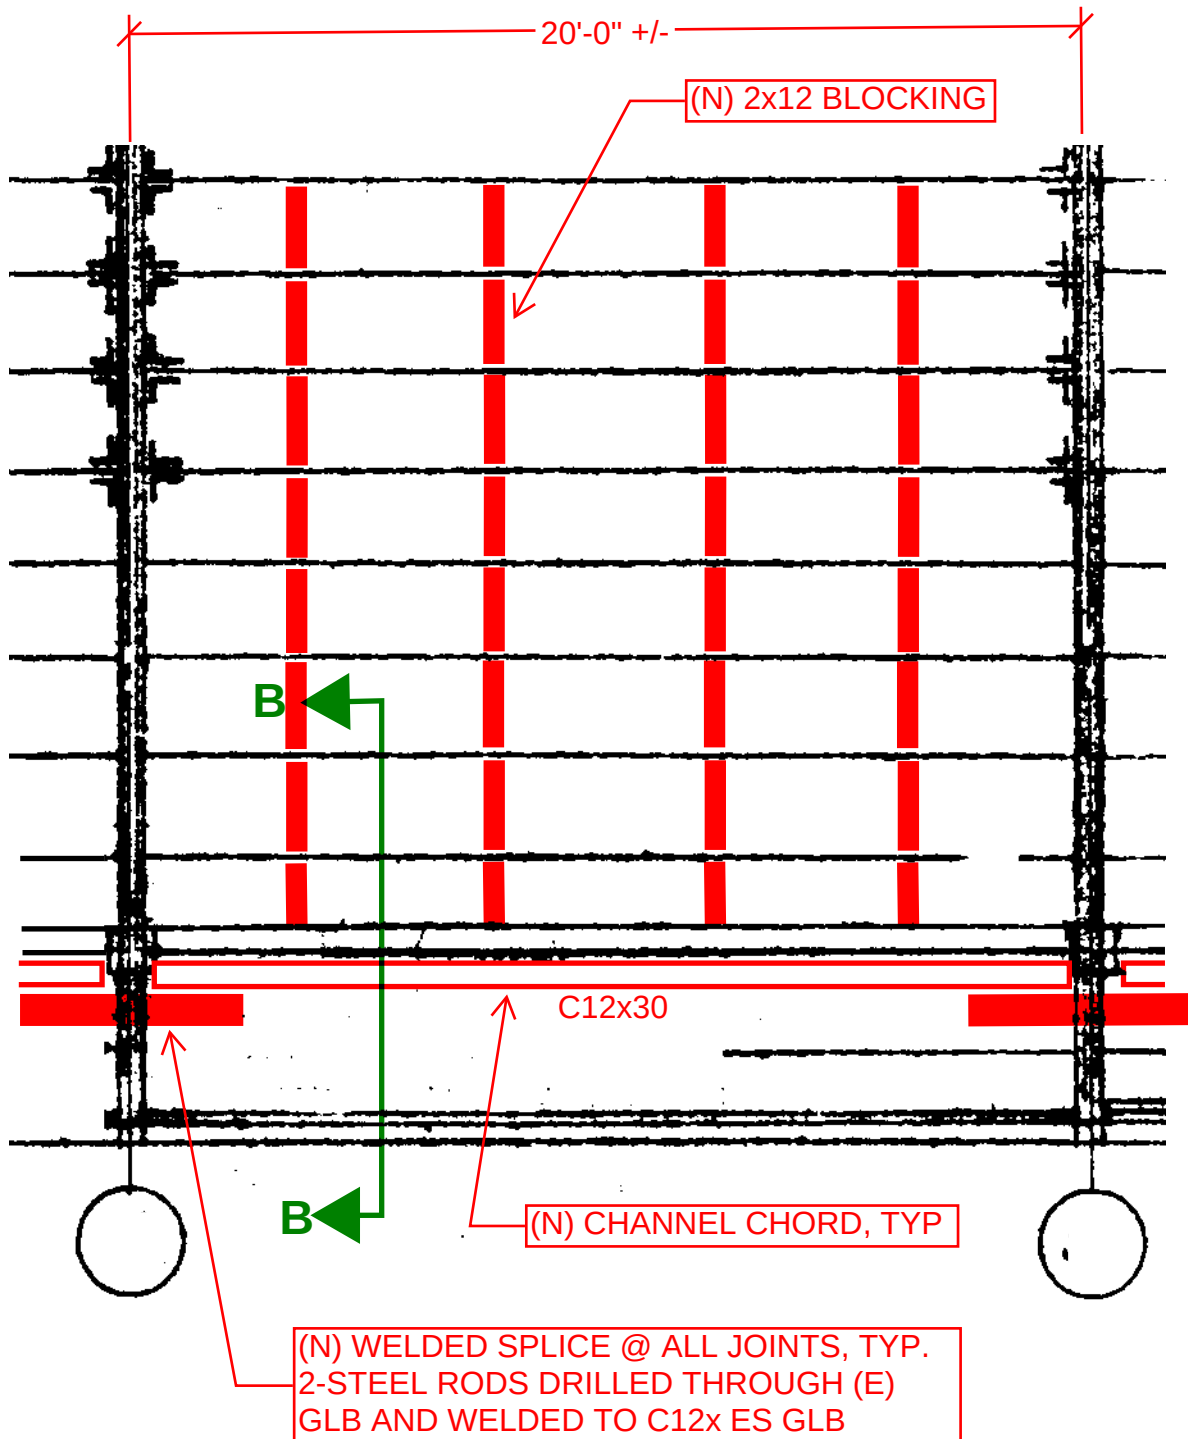
TYPICAL SUB-DIAPHRAGM BAY  
IMPROVEMENT @ TILT-WALL

- **The roof framing adjacent to concrete panels does not appear strong enough to develop out-of-plane wall forces into the diaphragm.** Recommend strengthening diaphragm and connections adjacent to all concrete tilt-wall panels through the addition of sub-diaphragms.

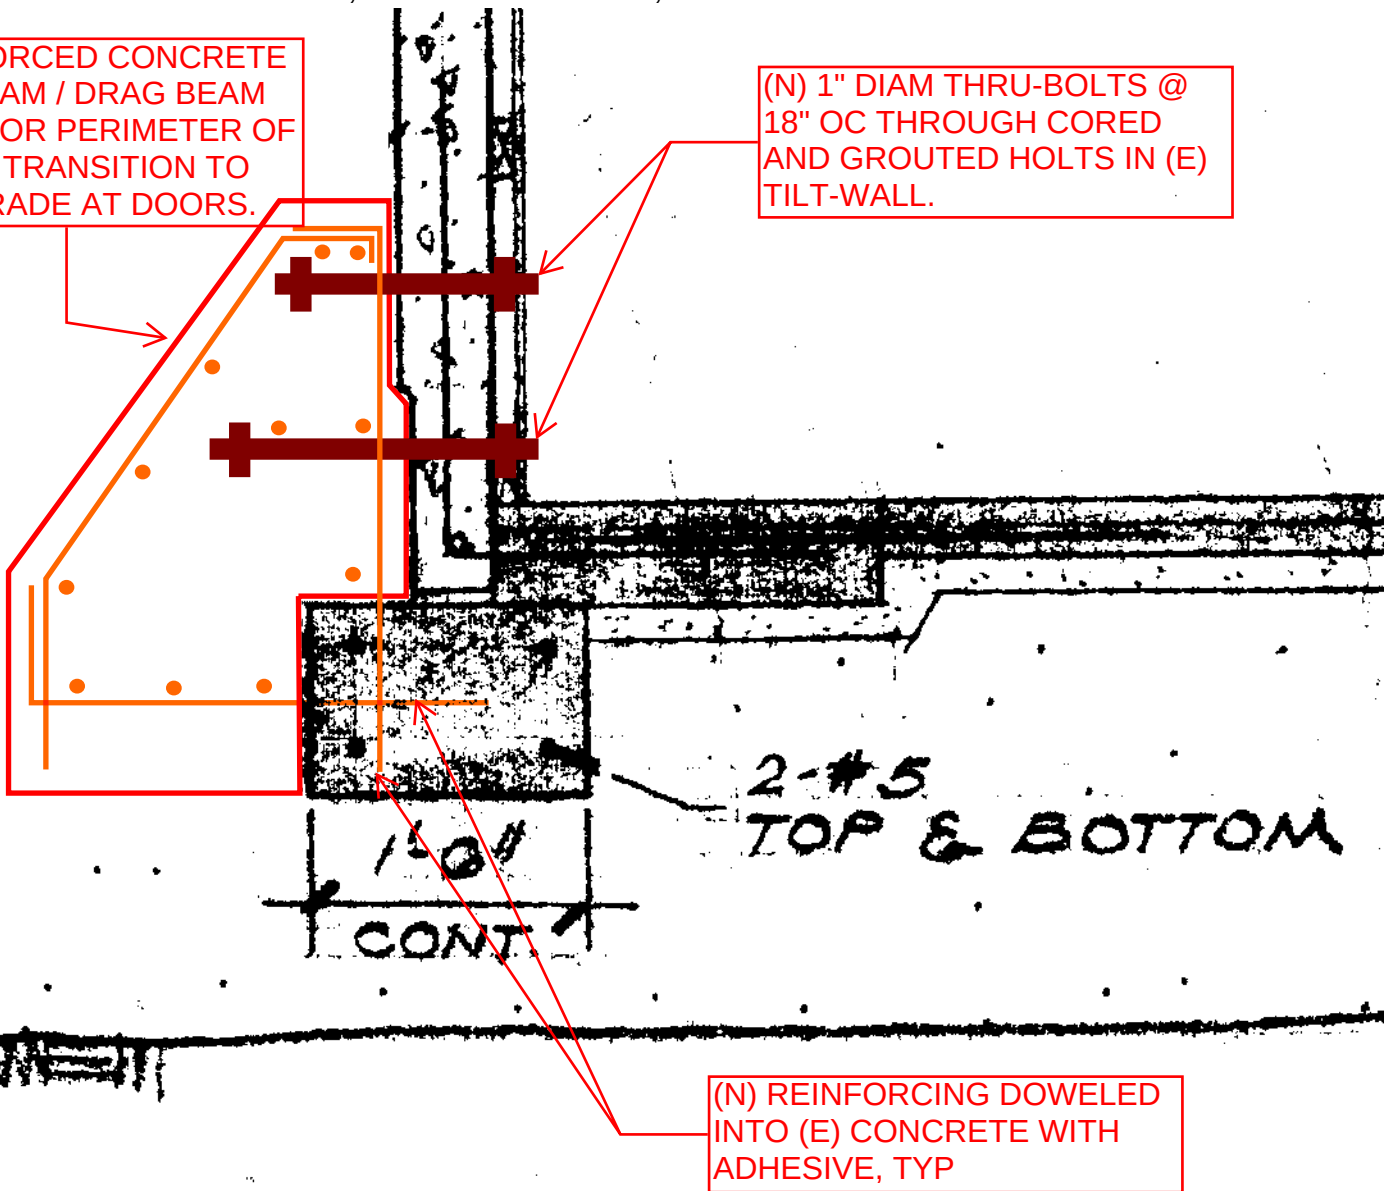
## TYPICAL LOW-BAY TILT-WALL FOUNDATION ATTACHMENT & DRAG

- **Tilt walls are not doweled to the foundation to transfer seismic shear.** Recommend that new exterior (and interior at Grid D and Grid 6 at the High Bay) grade beams be placed with post-installed reinforcing dowels and pot installed bolts added to structurally connect the tilt-wall panels to the foundation. The grade beam should also be sized to transfer current code seismic loads to the soil.

(N) REINFORCED CONCRETE  
GRADE BEAM / DRAG BEAM  
AT EXTERIOR PERIMETER OF  
BUILDING. TRANSITION TO  
BELOW GRADE AT DOORS.

(N) 1" DIAM THRU-BOLTS @  
18" OC THROUGH CORED  
AND GROUTED HOLTS IN (E)  
TILT-WALL.

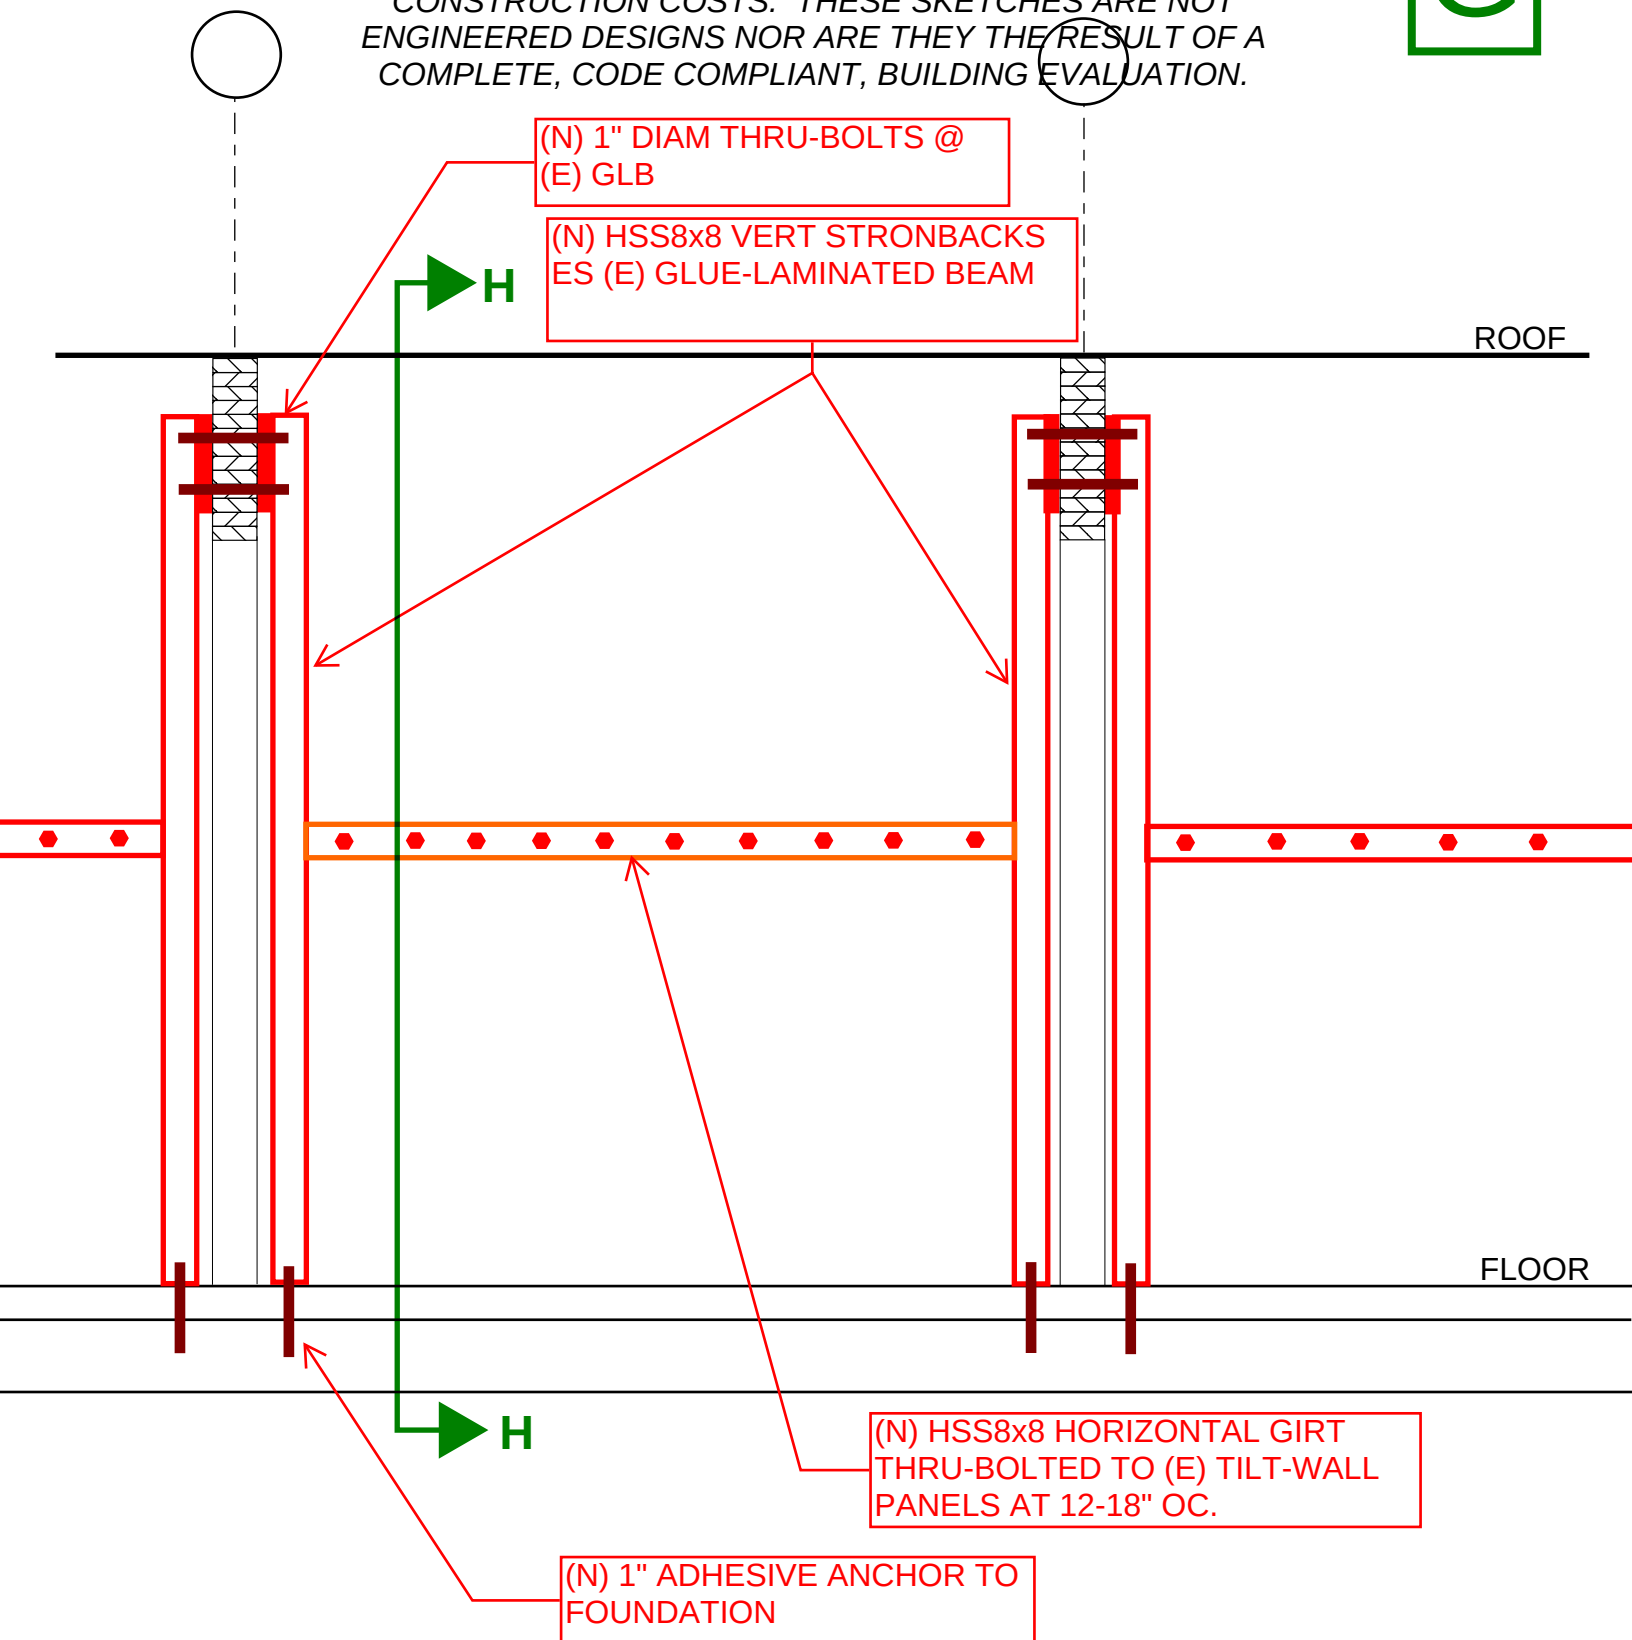
## TYPICAL HIGH-BAY TILT-WALL OUT-OF-PLANE STRENGTHENING

- **Tilt-walls are overstressed for out-of-plane loading, especially in the high-bay spans taller than 24'.** Recommend bracing the panels against out-of-plane loads mechanically near their mid-point via steel strong-backs. Options to strengthen the tilt-walls through shotcrete will add additional seismic mass to the building which is undesirable. Strengthening through the use of externally bonded FRP may be cost prohibitive.
