**Federal Aviation  
Administration**

Merced Regional/Macready Field  
Merced California  
Letter of Correction

The periodic certification inspection of the Merced Regional/Macready Field (MCE) was conducted 17-19 Nov 2014. The inspection revealed that the airport is not being operated in compliance with 14 CFR Part 139, the Airport Certification Manual (ACM), and the Airport Operating Certificate.

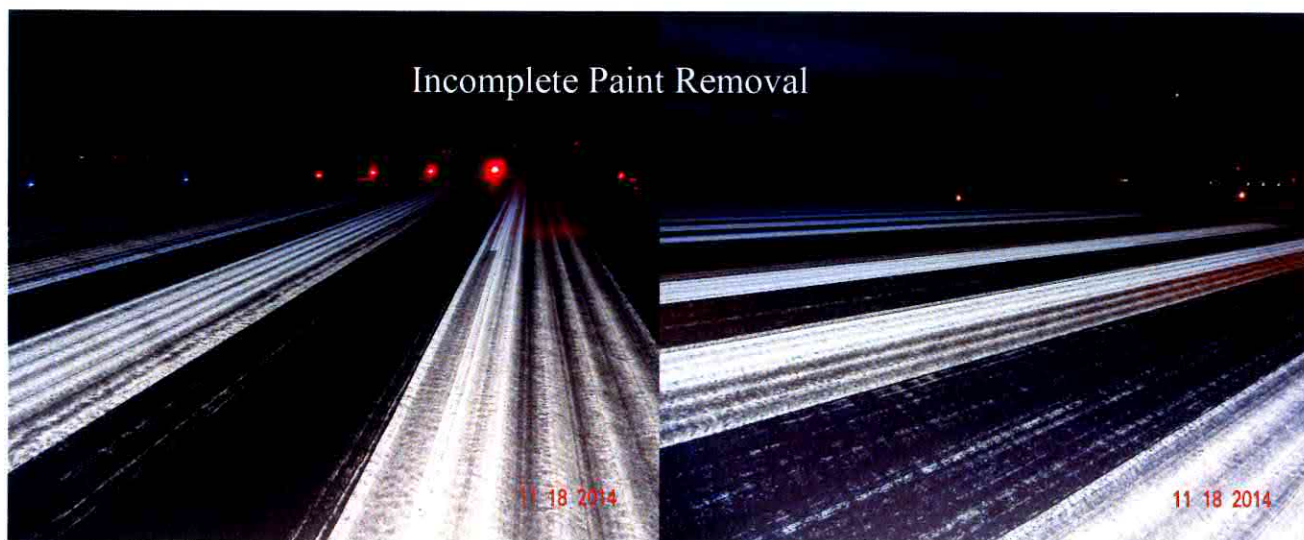
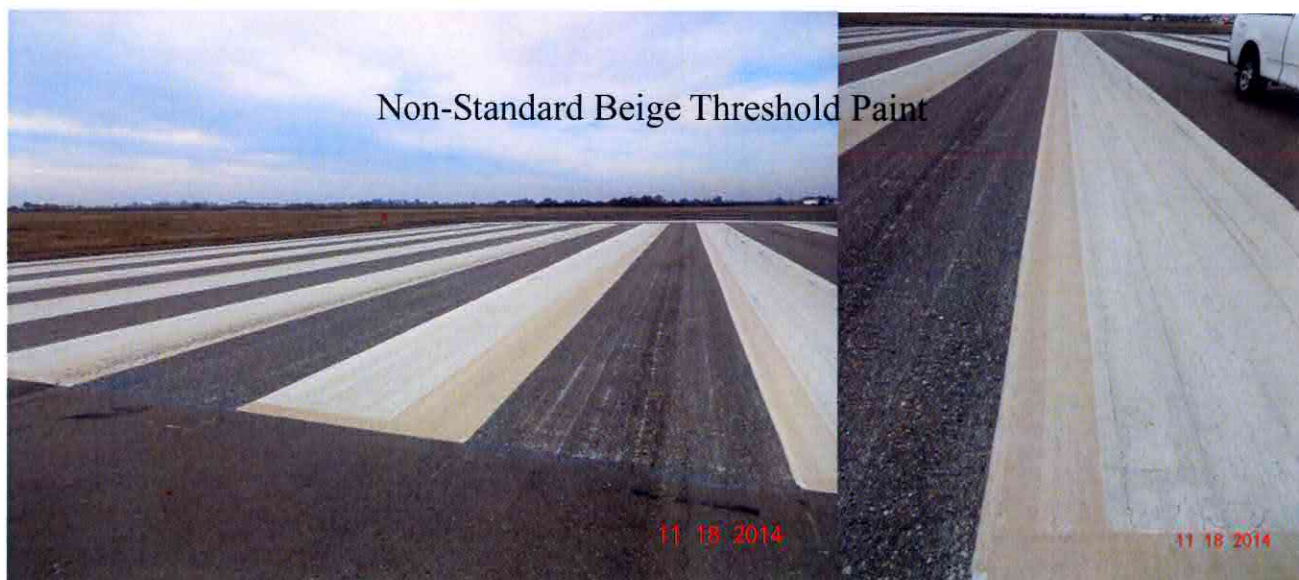
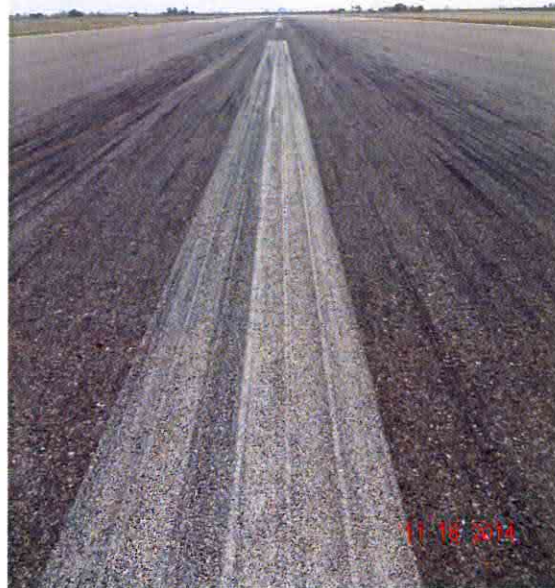
**§139.311(a)(1) – Runway Markings.** The certificate holder failed to maintain runway markings. Runway 12-30 centerline markings were found badly faded. Runway designation and threshold markings exhibited both white and beige hues. Where the threshold markings width was decreased, remnants of the white paint is still visible during daytime and hours of darkness. Also, in some areas of the markings, the paint appeared to be missing beads. The certificate holder must ensure all runway markings meets the standards outlined in AC 150/5340-1, *Standards for Airport Markings*, current edition. Pavement markings that are no longer needed are not to be painted over but instead are to be physically removed. Physical removal of markings is achieved by water blasting, shot blasting, sand blasting, chemical removal, or other acceptable means that do not harm the pavement. The physical removal of any old marking(s) must include a pre-determined larger size and shape of a removal area that encompasses the old marking(s) and by grouping adjacent markings together into a larger rectangular removal area.

Faded Runway Centerline

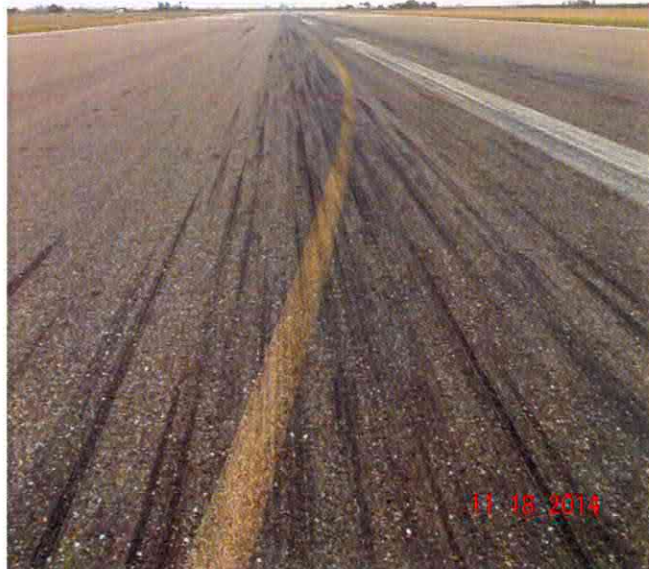
**§139.311(a)(2) – Taxiway Markings.** The certificate holder failed to maintain taxiway centerline markings. Taxiway centerlines were found badly faded. Additionally, not all lead-on/off lines that lead to the runway were visible. The certificate holder must ensure all taxiway markings meets the standards outlined in AC 150/5340-1, *Standards for Airport Markings*, current edition.

Faded Lead on/off line

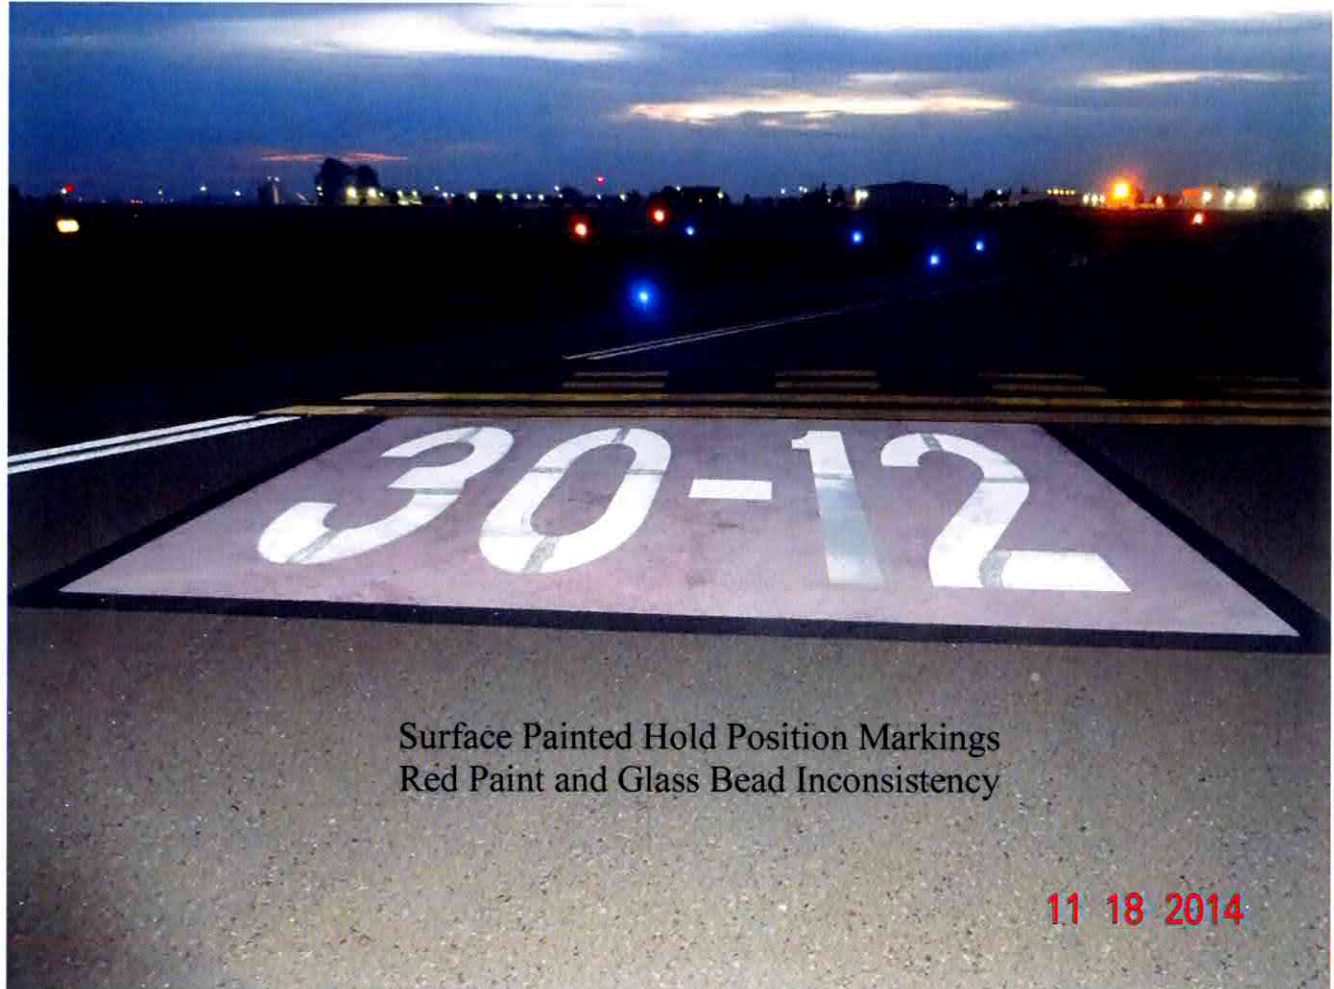
**§139.311(a)(4) – Holding Position Markings.** During hours of darkness, the red background of some surface painted holding position sign (SPHPS) markings appears pink. Additionally, the glass beads distribution appears to be inconsistent. The certificate holder must ensure all SPHPS markings meets the standards outlined in AC 150/5340-1, *Standards for Airport Markings*, current edition and provide the required supplemental visual cues that alert pilots and vehicle drivers of an upcoming holding position location.

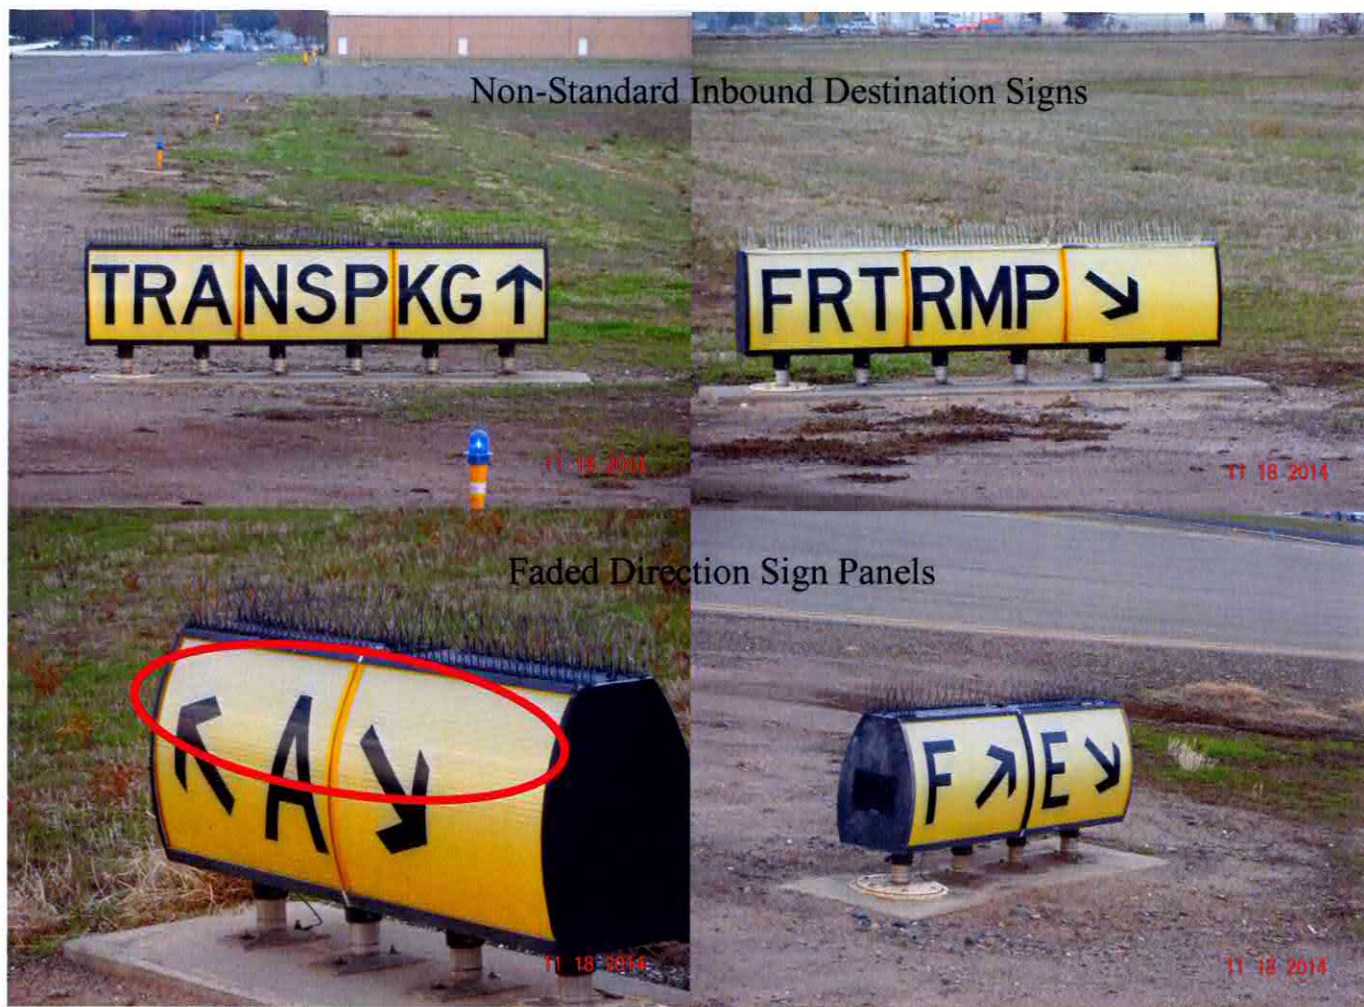
**§139.311(d) – Signs.** The certificate holder failed to maintain signs identifying taxiing routes on the movement area. Due to direct sunlight on some parts of the airfield, some direction sign panels were found faded and require replacement. Non-standard inbound destination signs were also found. Common names and abbreviations used for inbound destinations are: APRON - general parking, servicing, and loading areas; RAMP -synonymous with APRON; FUEL -areas where aircraft are fueled or serviced; TERM -gate positions at which aircraft are loaded or unloaded; CIVIL-areas set aside for civil aircraft; MIL -areas set aside for military aircraft; PAX -areas set aside for passenger handling; CARGO -areas set aside for cargo handling; INTL -areas set aside for handling international flights; and FBO -fixed-base operator. The certificate holder must conduct a thorough inventory of all signs, ensure compliance with A/C 150/5340-18F, *Standards for Airport Sign Systems*, and replace as required.

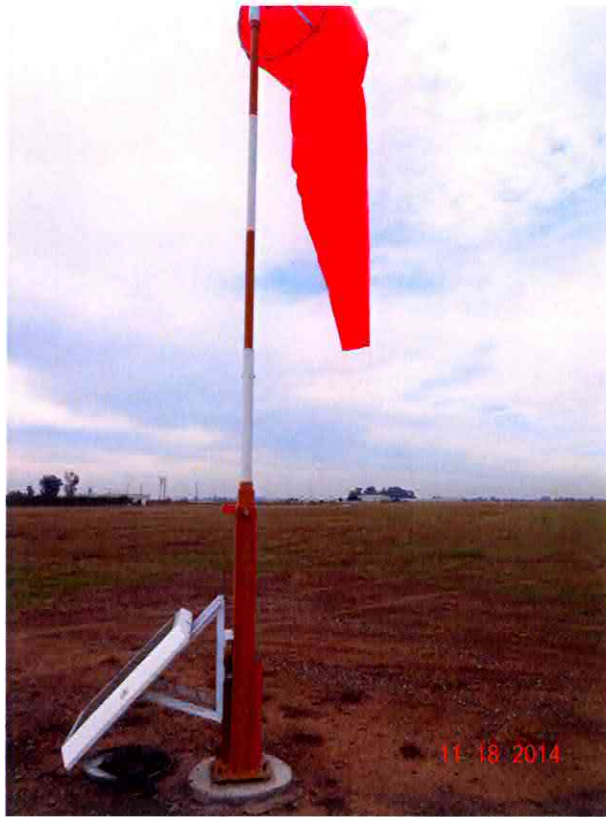
**§139.323 - Traffic and wind direction indicators.** Runway 30 supplemental wind cone was found in the Runway Object Free Area (ROFA). The wind cone is located approximately 275 feet from the runway centerline, not fixed-by function, and must be moved out of the ROFA. The supplemental wind cone must be located near the runway end so that pilots have an unobstructed view during either landing or takeoff operations. The preferred location is on the left side of the runway when viewed from a landing aircraft. However, it may be located on the right side of the runway where conditions such as the existence of another runway, taxiway, apron, terrain problems, or navigational aids preclude its installation on the left side. The certificate holder must work with the SFO Airport District Office to address this 139 violation and correct at the earliest opportunity.
