City of Merced CA

## Sun Star Building Evaluation

Prepared by  
WMB Architects

February 23, 2016

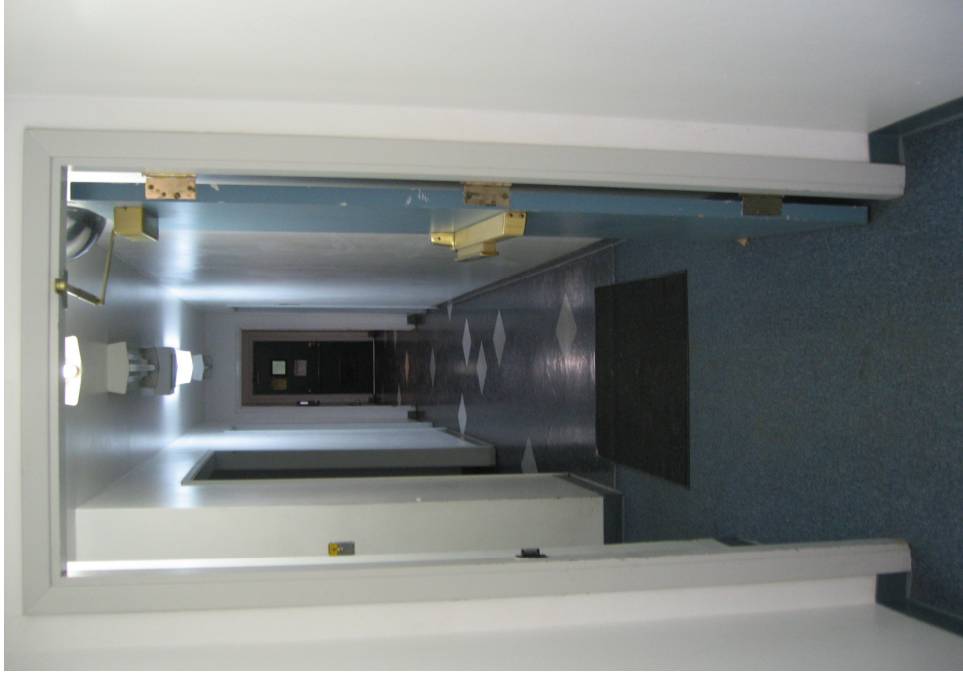
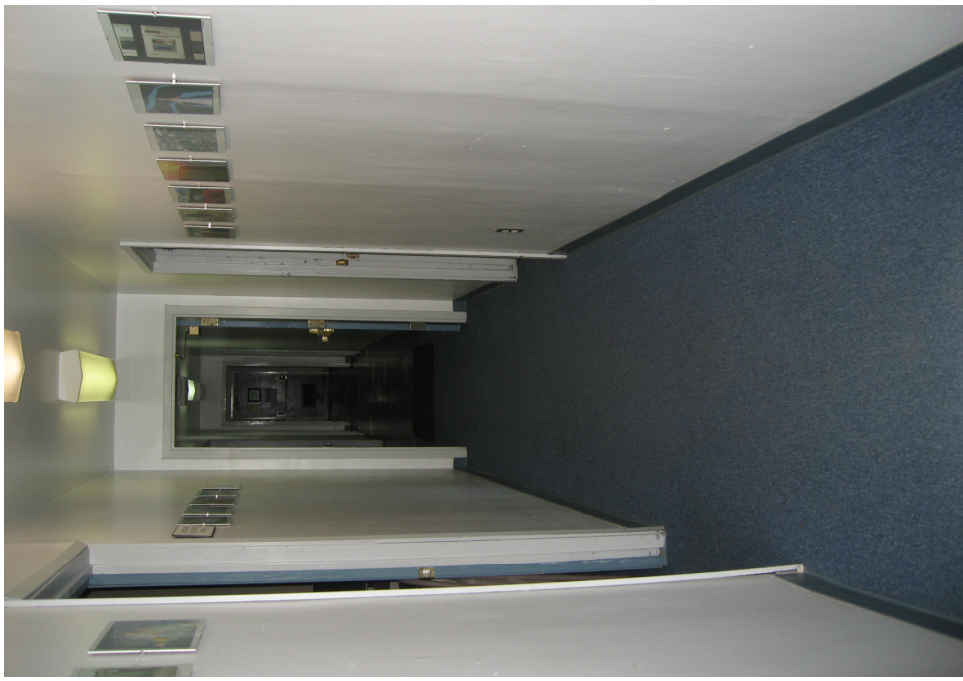
Interior doors without 18" push side clearance

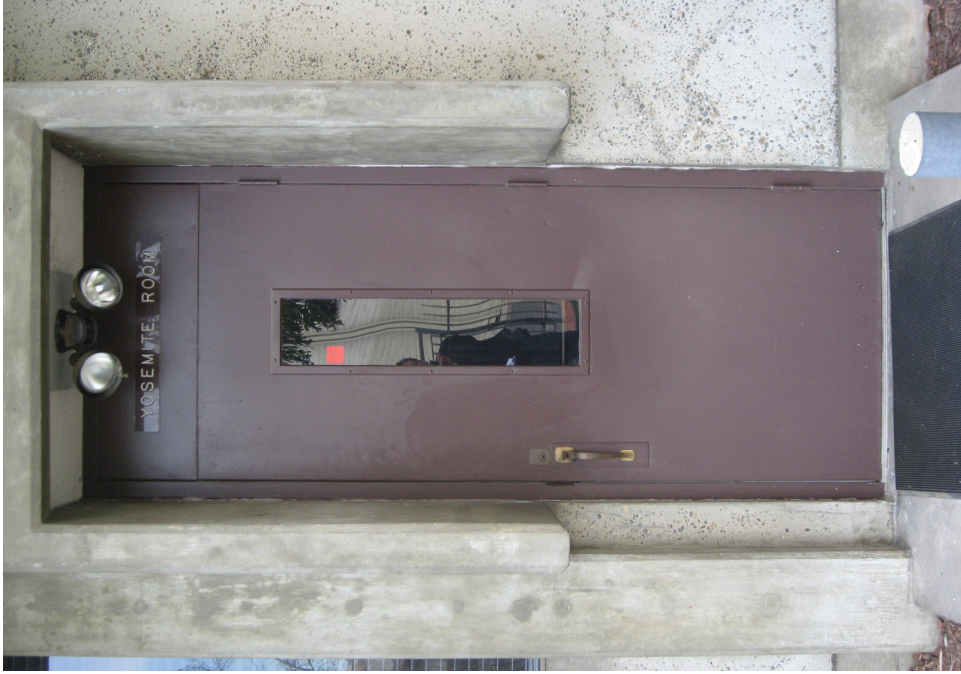
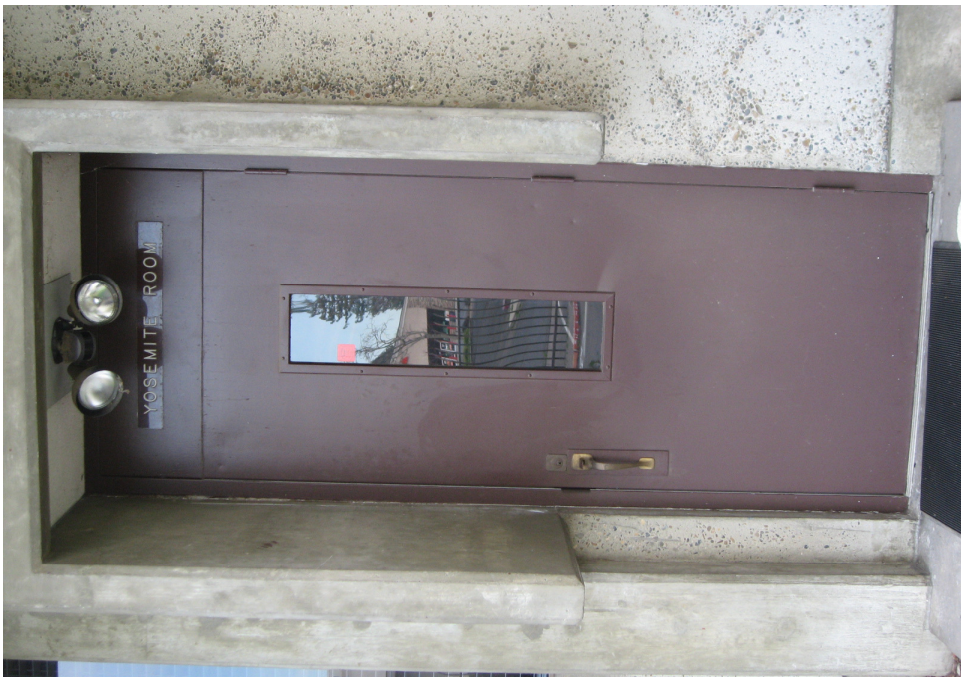
The exterior doors at A | 7 and G | 7 do not have the required 24" side clearance because of the concrete column at the door jamb which is greater than 8" in depth. The door and frame must be pulled-out to the face of the column (or replaced), and the interior gypsum wall patched and refinished. For purposes of this study and estimate, we assume the door re-used and relocated.

Exterior doors without 24" side clearance - concrete portico interference

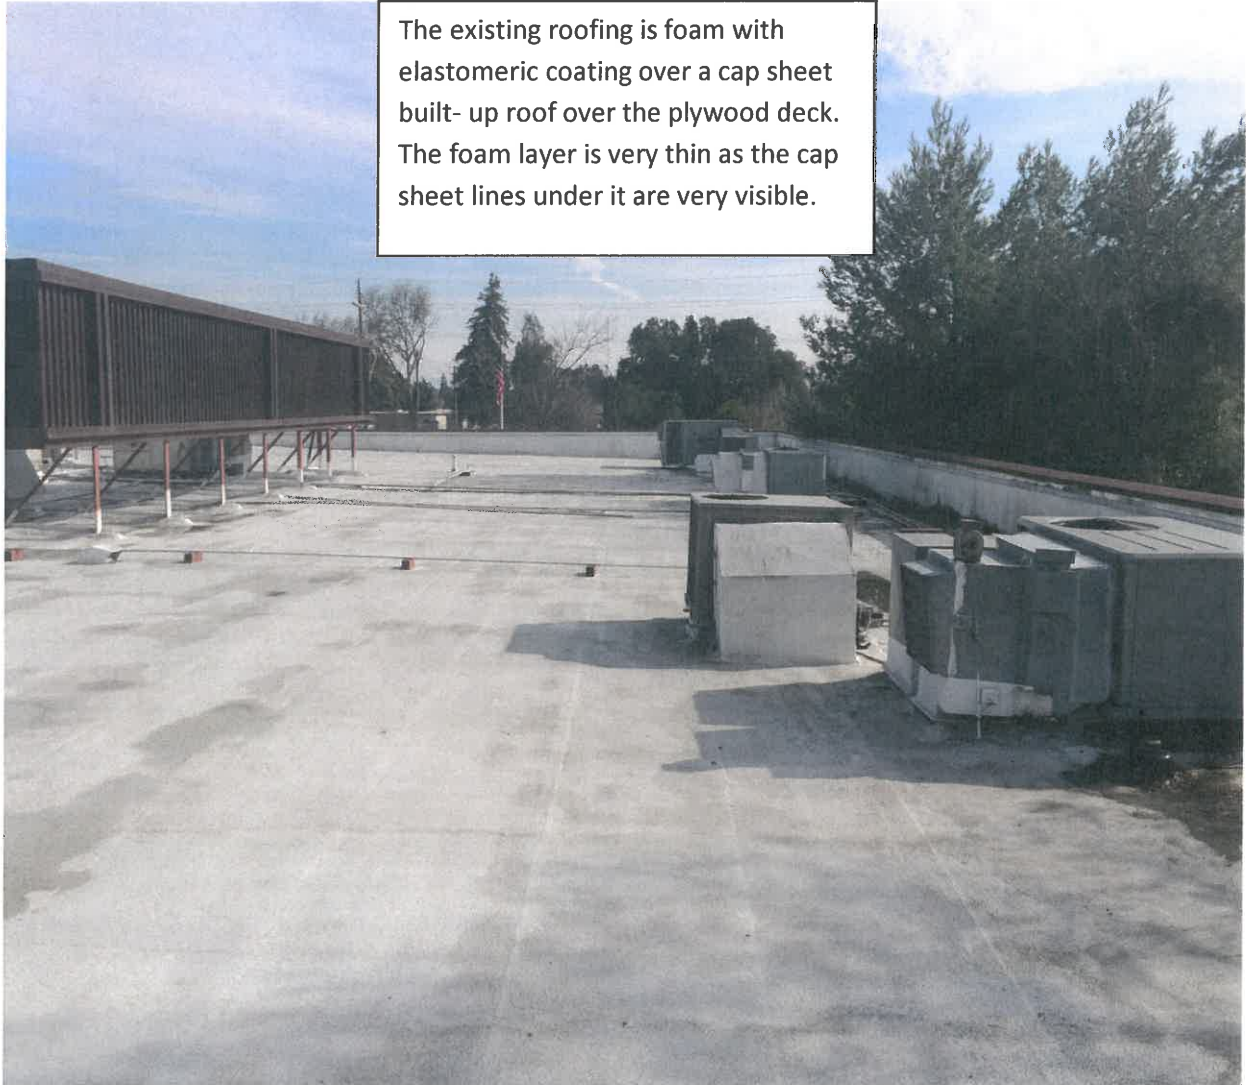
The existing roofing is a thin foam spray system over the existing original built-up asphalt roofing. The foam roofing is beyond its life expectancy and should be removed. Further, the extent of structural retrofit work will require the removal and replacement of all roofing. Additional tapered insulation cants should be installed at the low portions of the roof to assist in better water flow to roof drains. The plastic roof drains and overflows should be replaced with cast iron units throughout.

The existing roofing is foam with elastomeric coating over a cap sheet built- up roof over the plywood deck. The foam layer is very thin as the cap sheet lines under it are very visible.

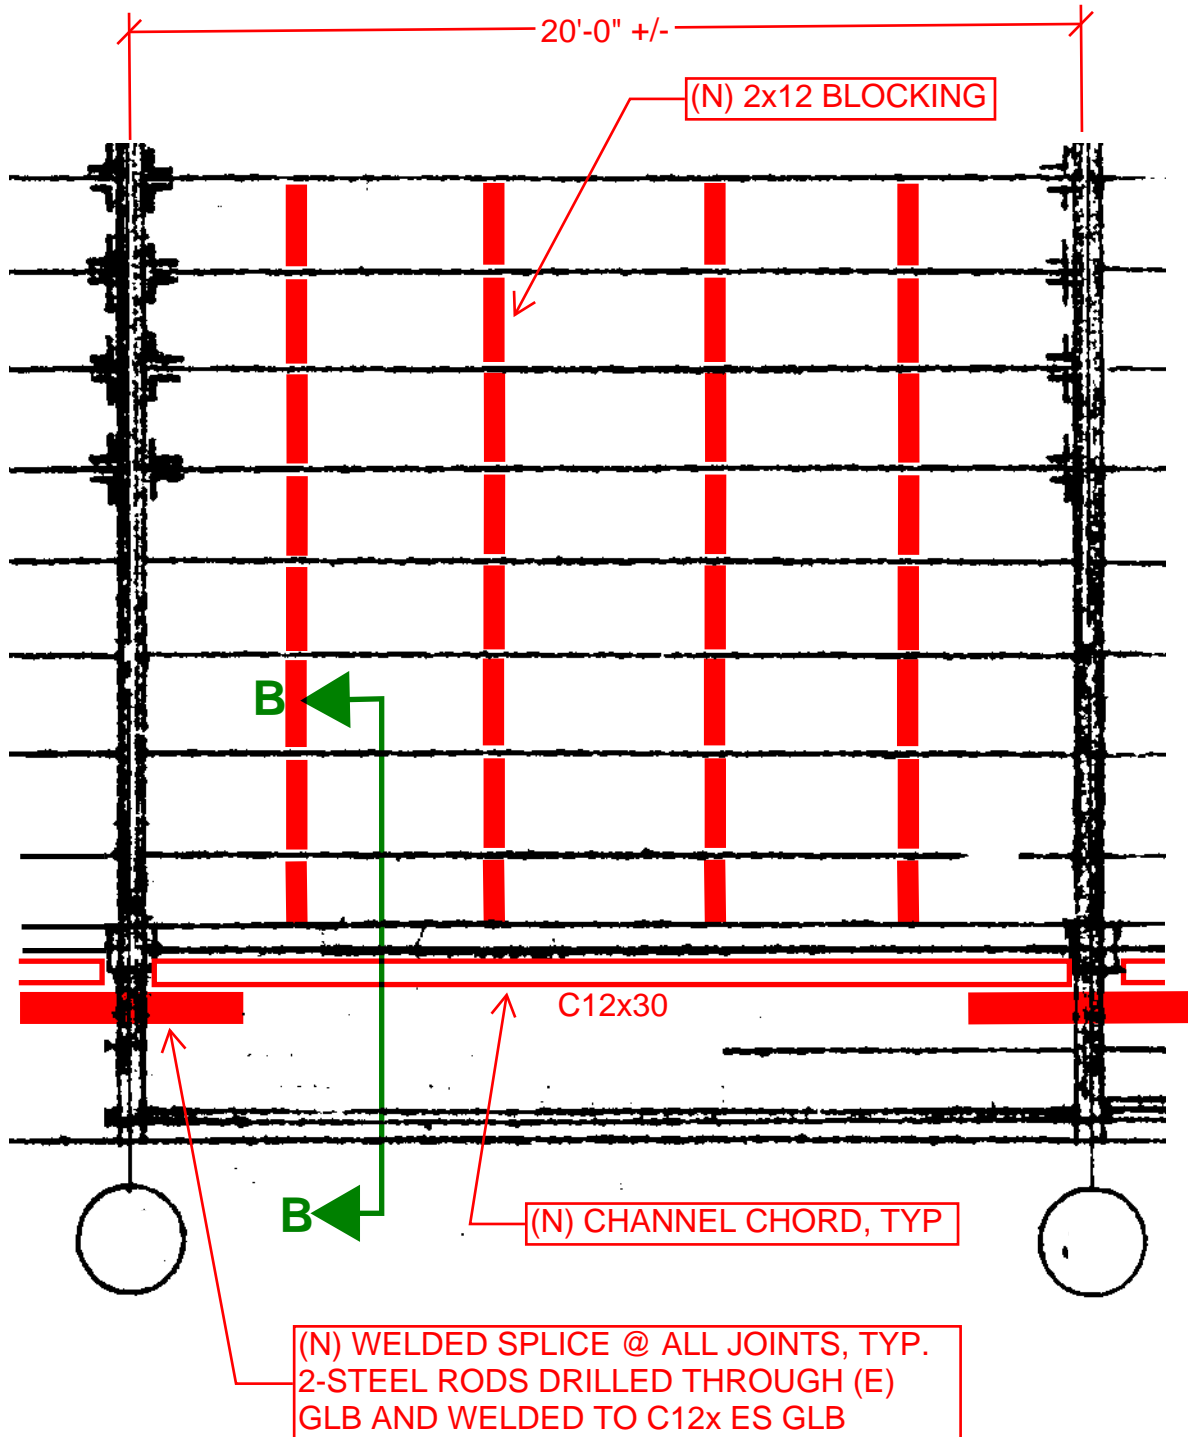
TYPICAL SUB-DIAPHRAGM BAY  
IMPROVEMENT @ TILT-WALL

- **The roof framing adjacent to concrete panels does not appear strong enough to develop out-of-plane wall forces into the diaphragm.** Recommend strengthening diaphragm and connections adjacent to all concrete tilt-wall panels through the addition of sub-diaphragms.

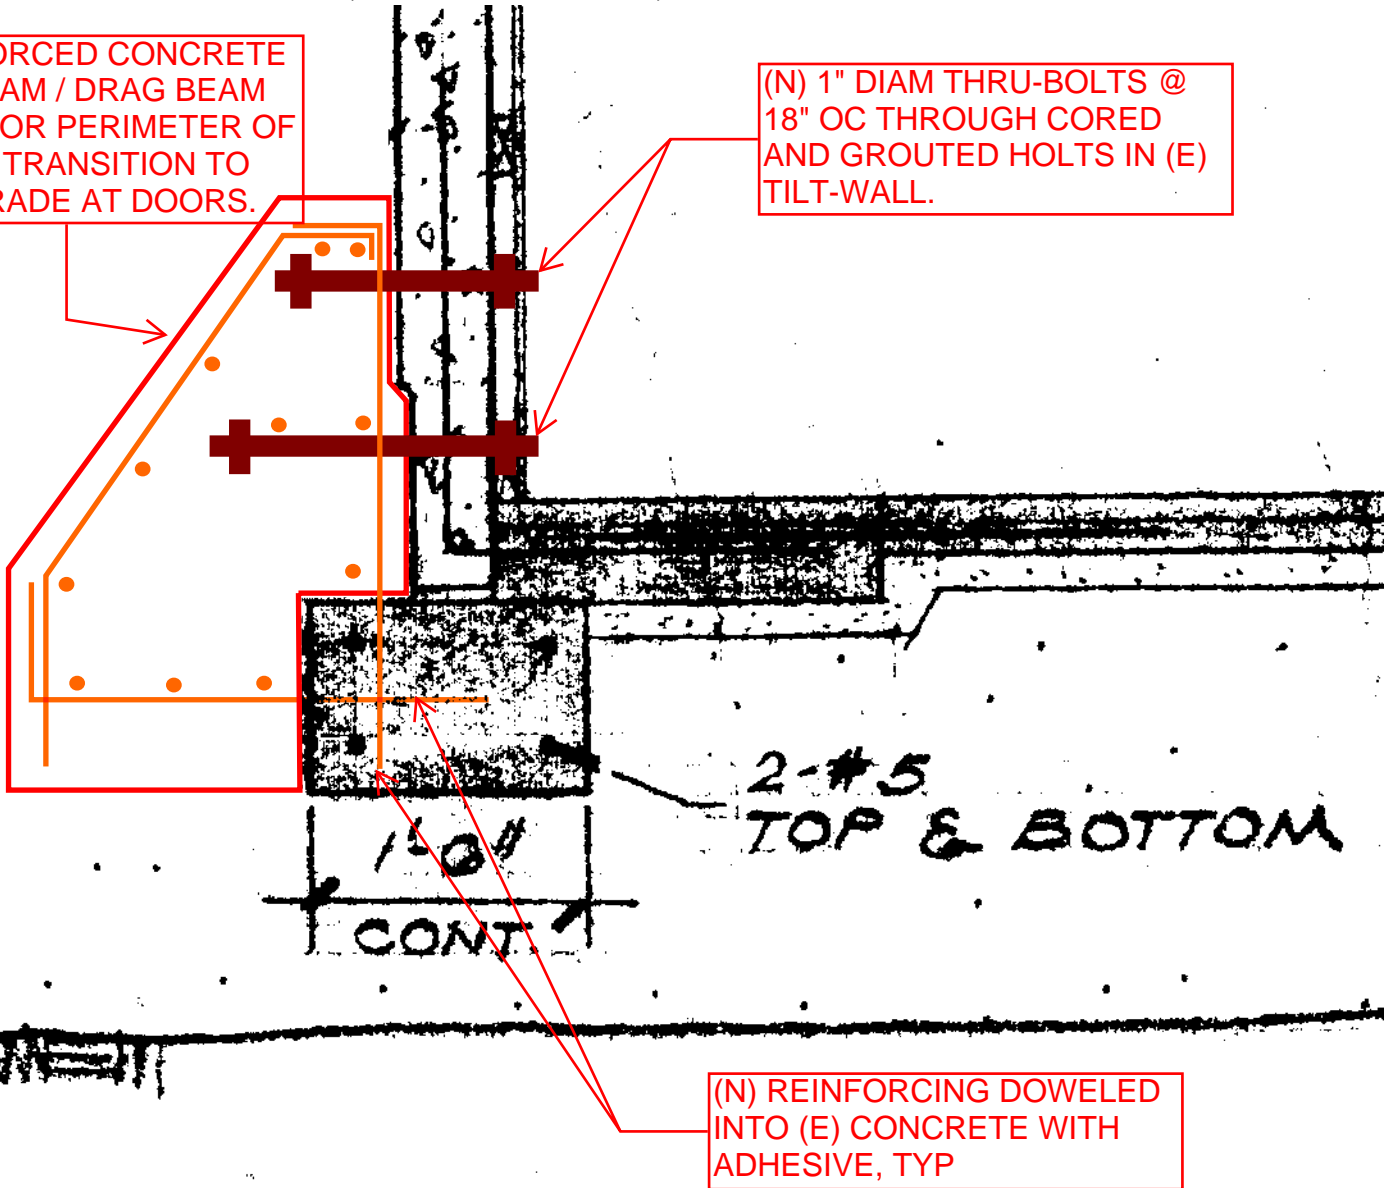
## TYPICAL LOW-BAY TILT-WALL FOUNDATION ATTACHMENT & DRAG

- **Tilt walls are not doweled to the foundation to transfer seismic shear.** Recommend that new exterior (and interior at Grid D and Grid 6 at the High Bay) grade beams be placed with post-installed reinforcing dowels and pot installed bolts added to structurally connect the tilt-wall panels to the foundation. The grade beam should also be sized to transfer current code seismic loads to the soil.

(N) REINFORCED CONCRETE  
GRADE BEAM / DRAG BEAM  
AT EXTERIOR PERIMETER OF  
BUILDING. TRANSITION TO  
BELOW GRADE AT DOORS.

(N) 1" DIAM THRU-BOLTS @  
18" OC THROUGH CORED  
AND GROUTED HOLTS IN (E)  
TILT-WALL.

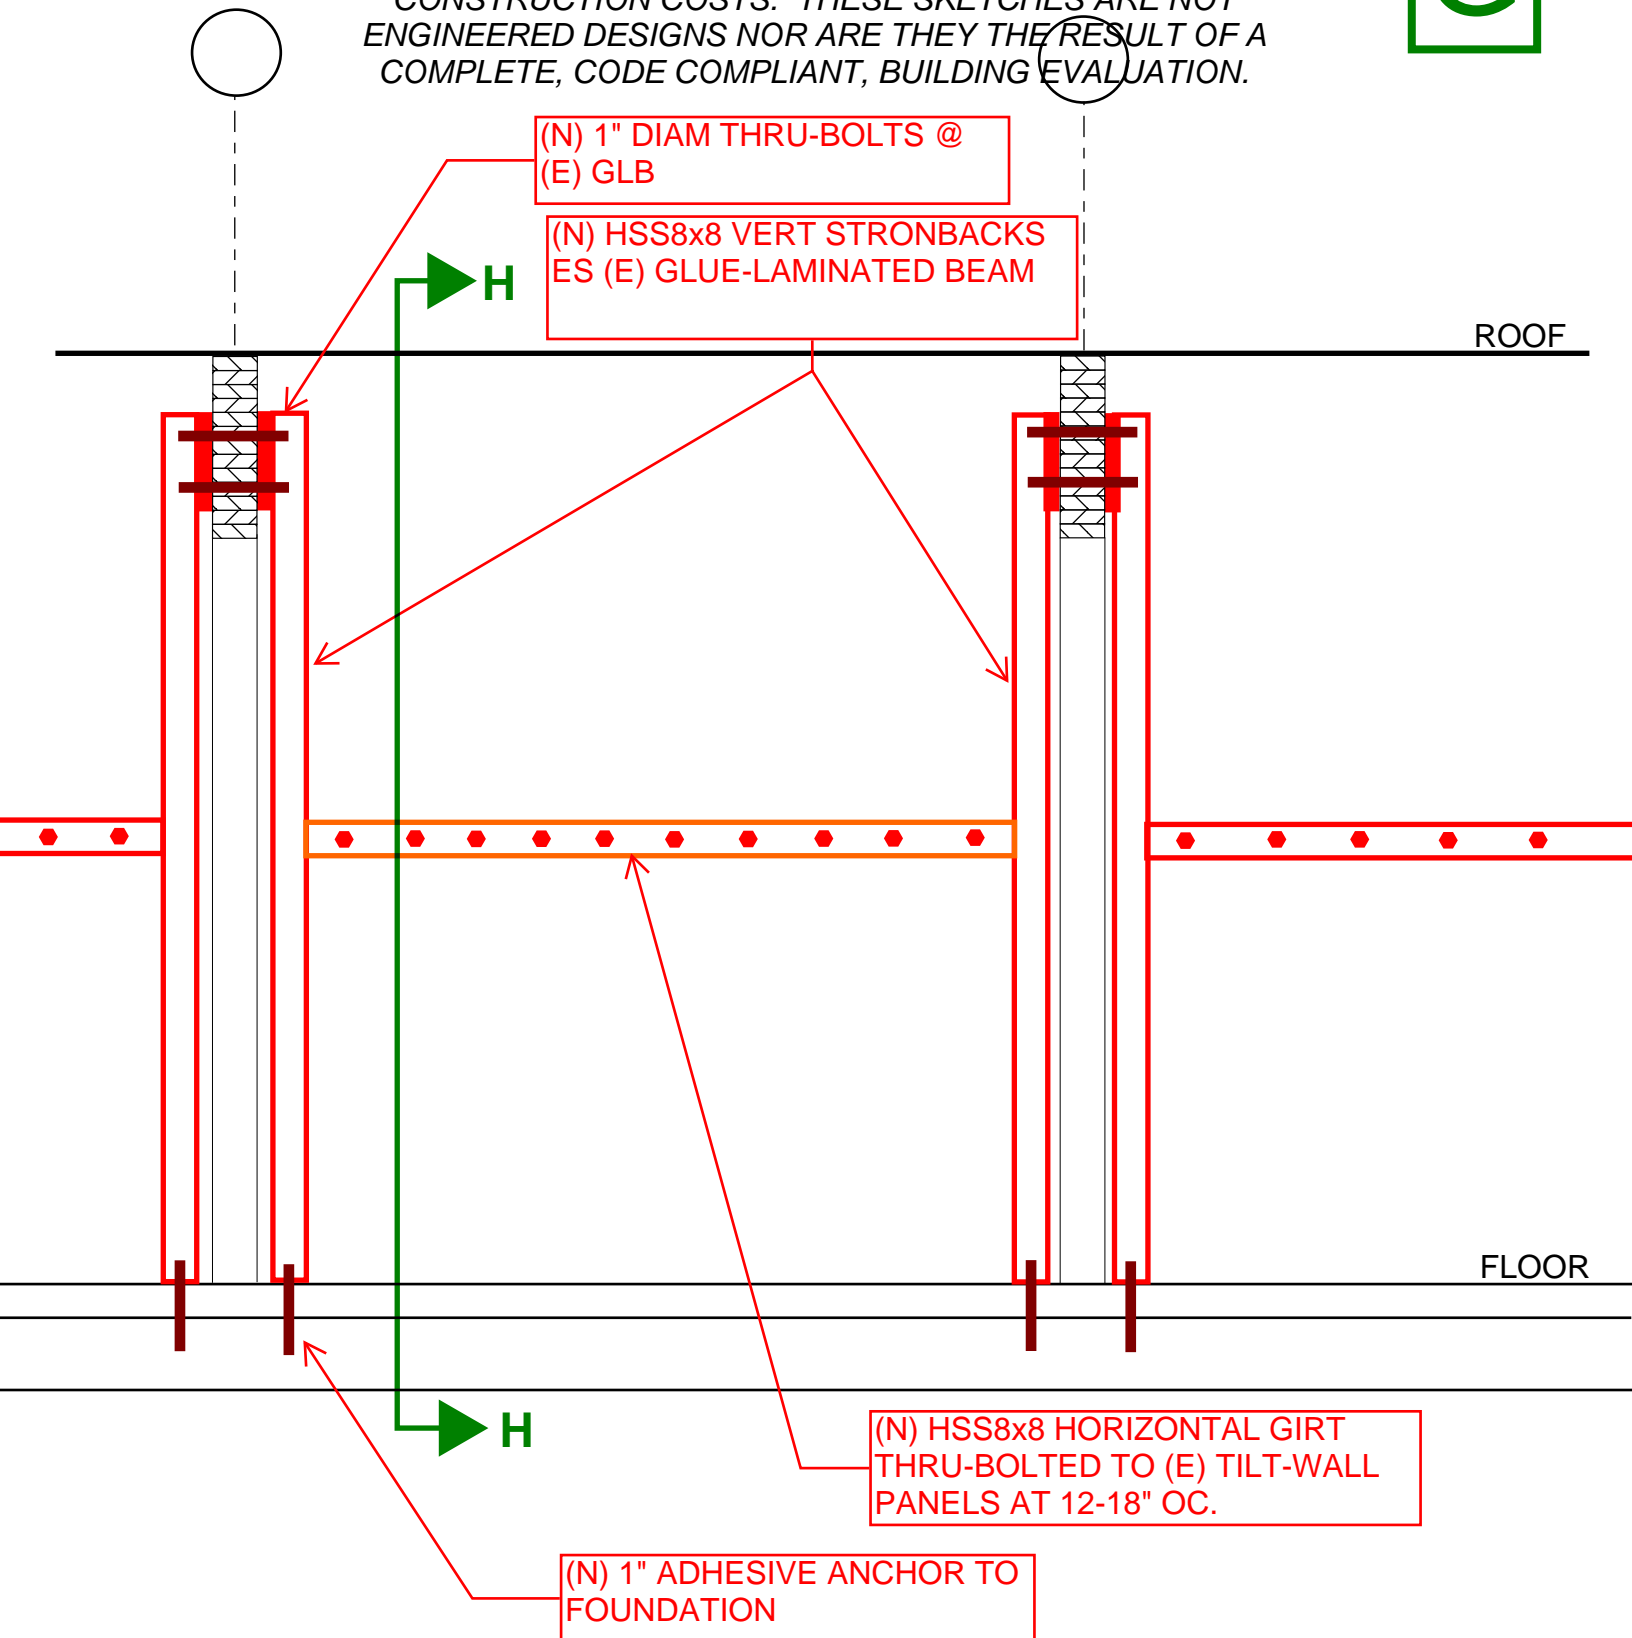
## TYPICAL HIGH-BAY TILT-WALL OUT-OF-PLANE STRENGTHENING

- **Tilt-walls are overstressed for out-of-plane loading, especially in the high-bay spans taller than 24'.** Recommend bracing the panels against out-of-plane loads mechanically near their mid-point via steel strong-backs. Options to strengthen the tilt-walls through shotcrete will add additional seismic mass to the building which is undesirable. Strengthening through the use of externally bonded FRP may be cost prohibitive.
