# Applegate Park Laura's Fountain Update

## Laura's Fountain

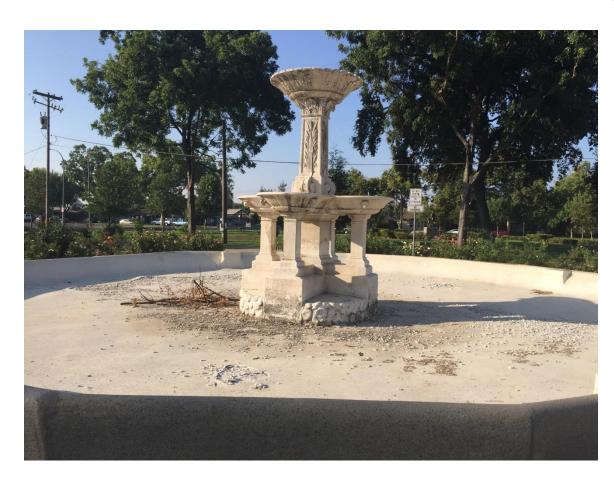
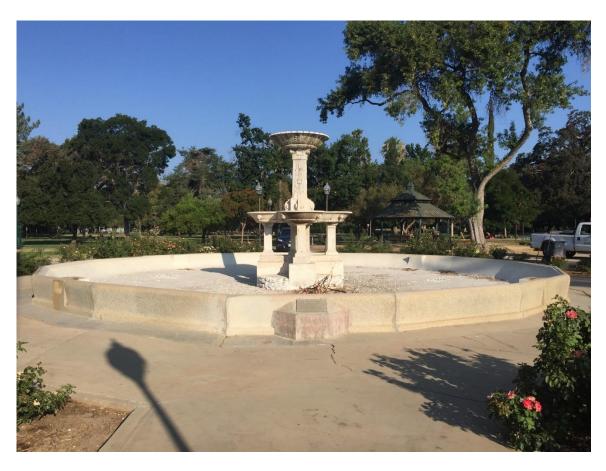
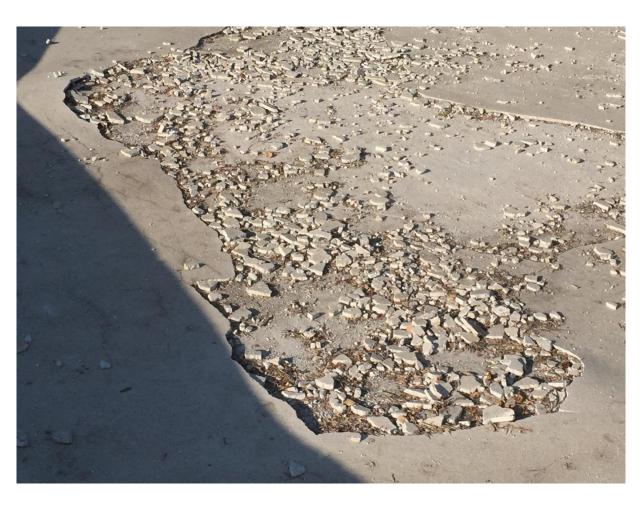
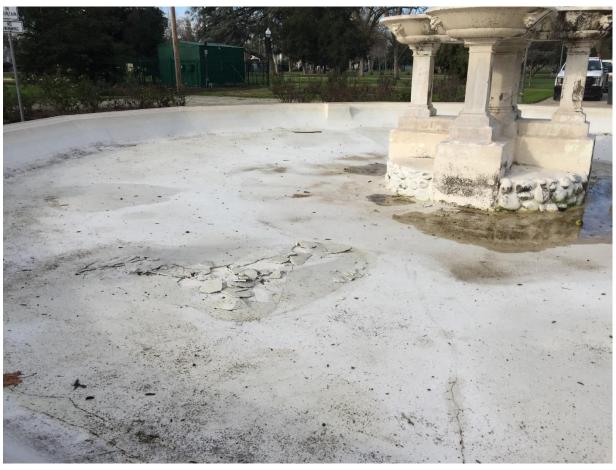
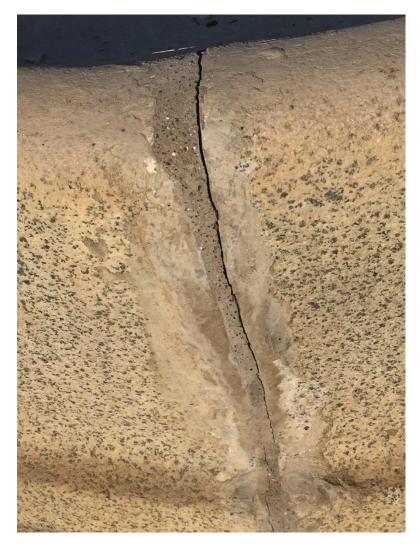
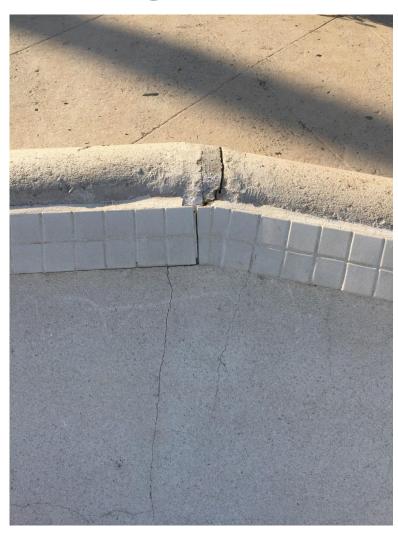
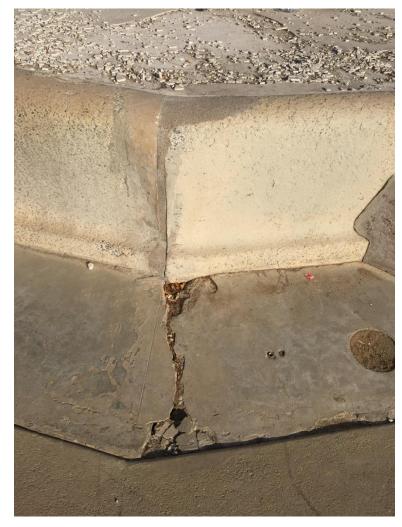
# Laura's Fountain – Existing Condition

- Concrete Slab around Fountain no reinforcing steel found
- Subsurface Soil Moderately expansive clay soil and saturated
- Shrink and swell cycles of clay soil causing movement, settlement and unevenness
- Shrink and swell cycles beneath fountain will continue in the future how much? variable

- Mitigate future potential shrink and swell of uncompacted fill under fountain concrete
- Provide a stable subgrade for fountain and surrounding concrete
- Option 1 Excavate and Recompact
  - Remove clayey soils and replace with non-expansive engineered fill
  - Minimum of 2 feet depth and placed in 8 inch horizontal lifts and compacted
- Option 2 Grout Injection
  - Densification of subgrade by injection of cement or polyurethane grout
  - Remove and replace concrete slab around fountain

- It is assumed that the Fountain sits on a concrete slab most likely with no steel
- It is recommended that a new steel reinforced concrete slab on grade (4" to 5" thick)
- Recommend a continuous spread footings be utilized to support the fountain
- Footings minimum embedment depth of 18 inches below lowest adjacent grade
- Restore fountain
