City of Merced CA

Sun Star Building Evaluation

Prepared by WMB Architects Project # 15-176 February 23, 2016

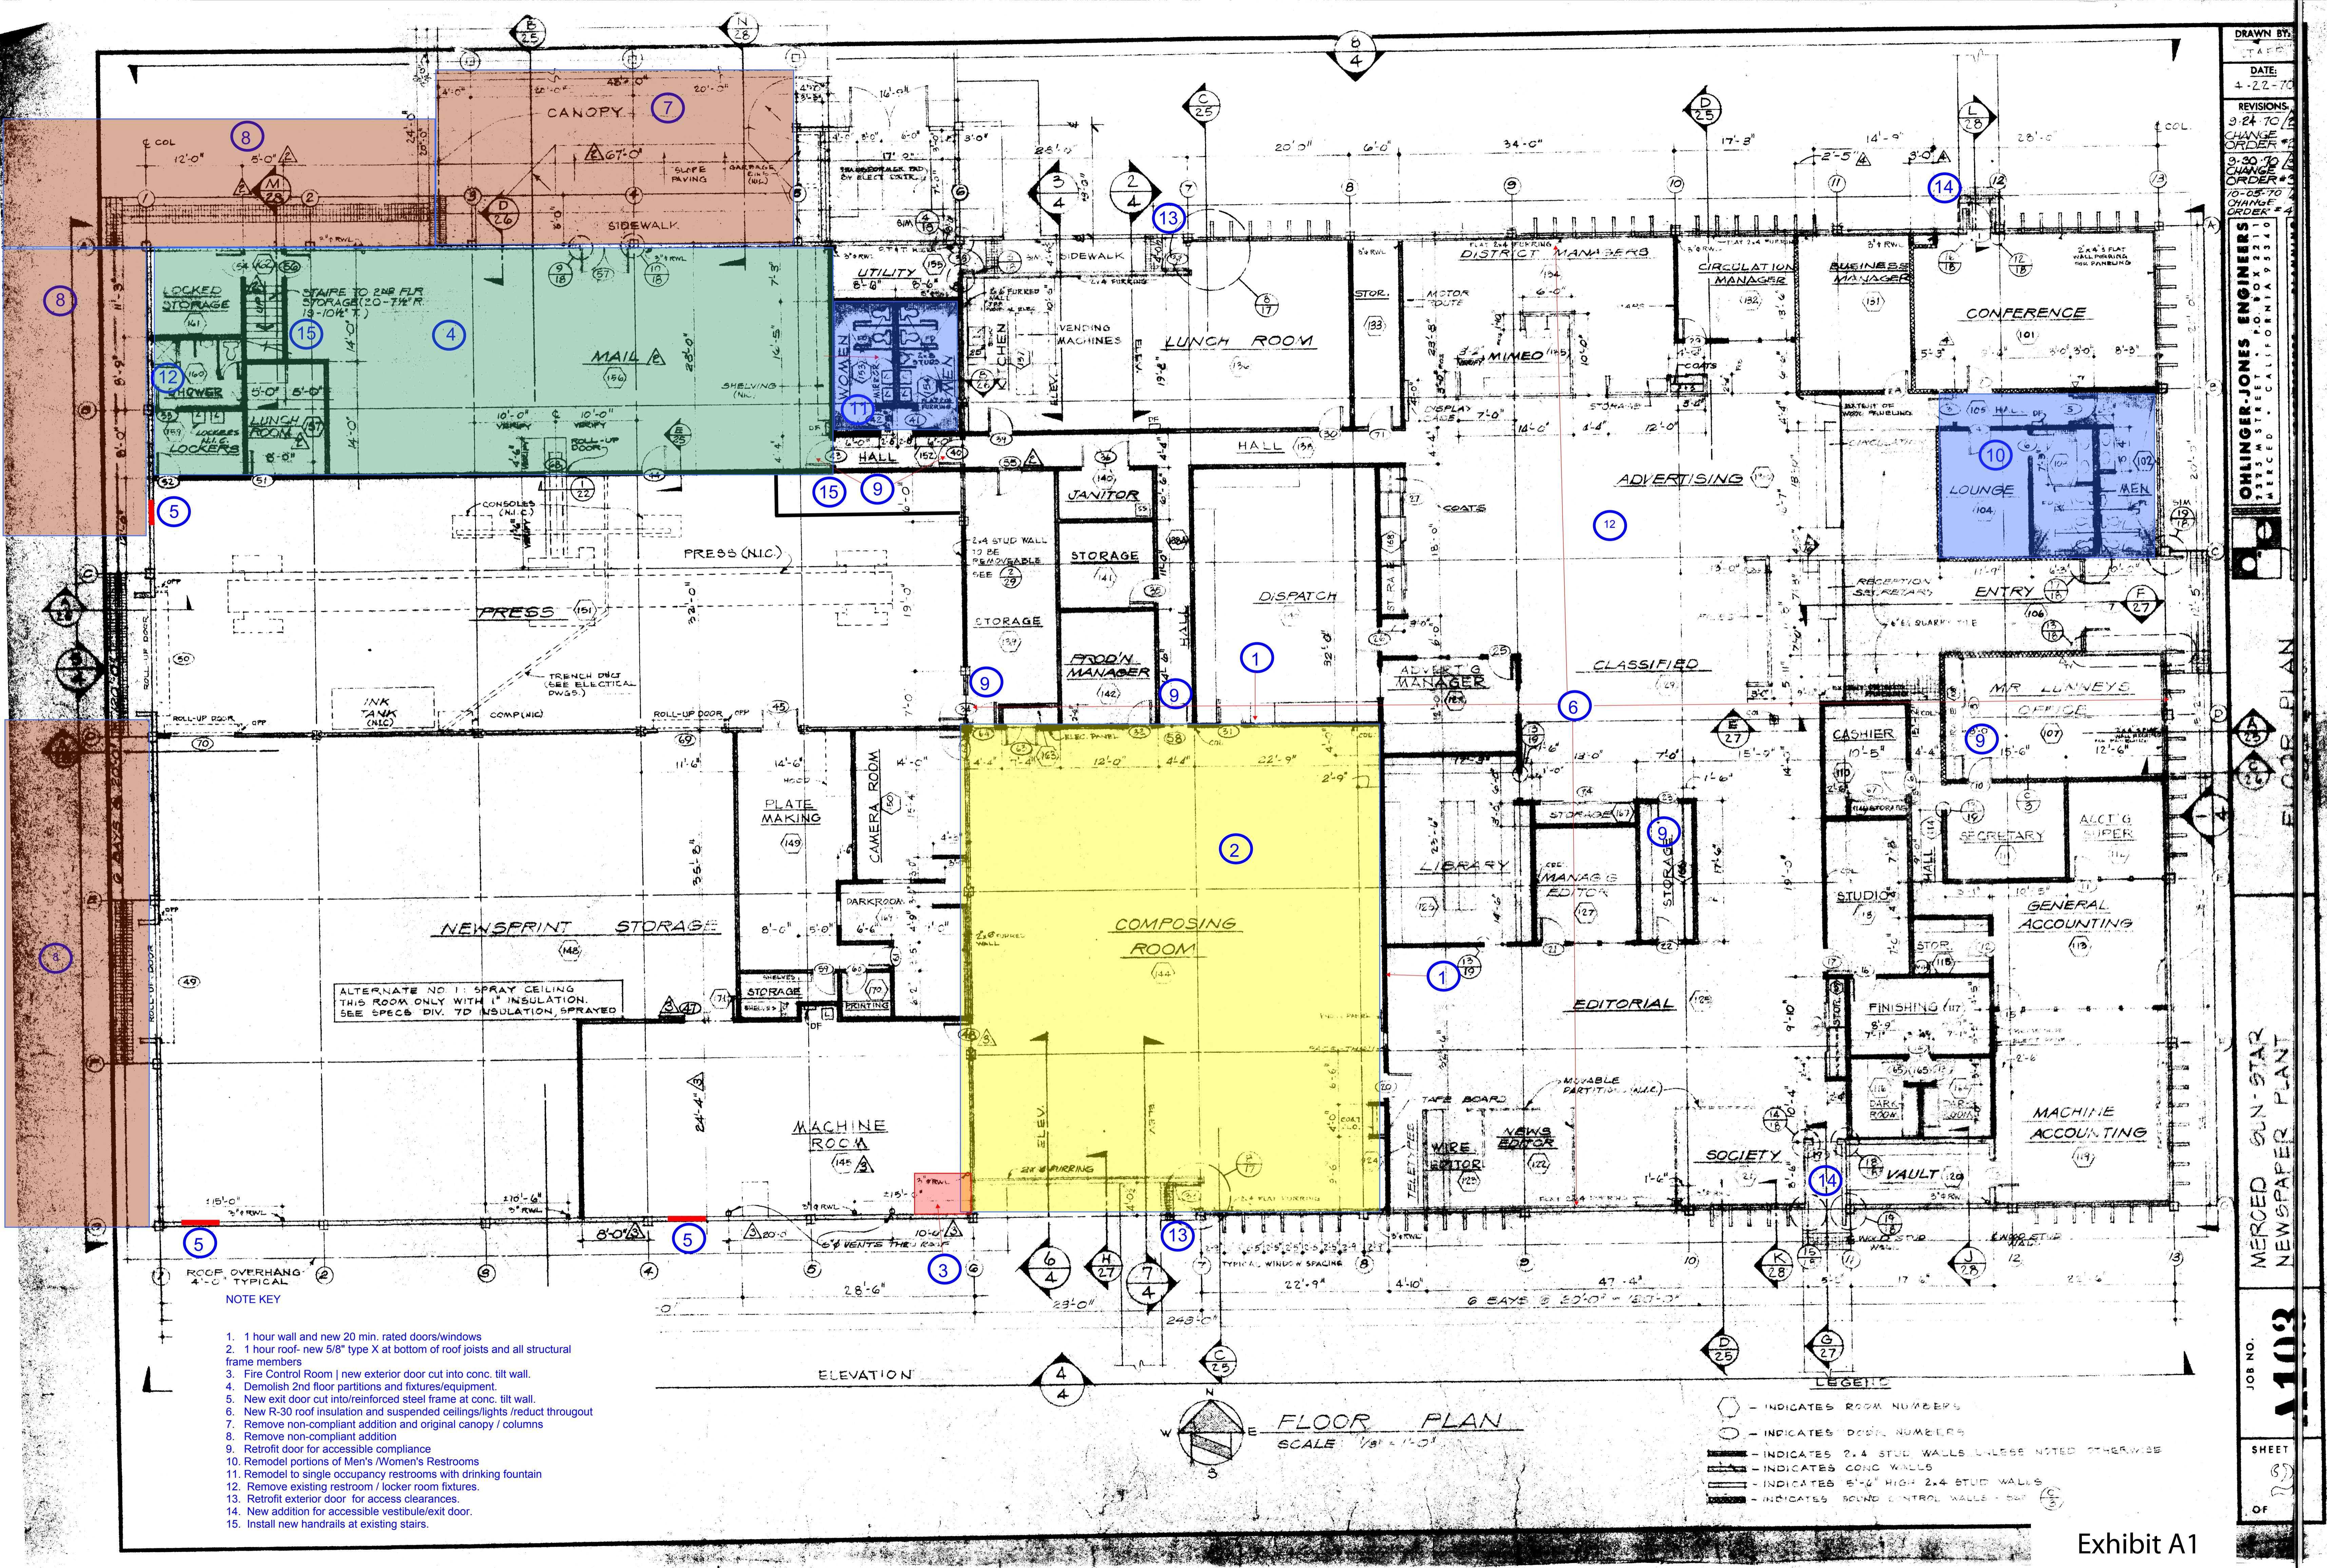
Exhibit P-1

The exterior doors at A | 7 and G | 7 do not have the required 24" side clearance because of the concrete column at the door jamb which is greater than 8" in depth. The door and frame must be pulled-out to the face of the column (or replaced), and the interior gypsum wall patched and refinished. For purposes of this study and estimate, we assume the door re-used and relocated.

Exterior doors without 24" side clearance - concrete portico interference

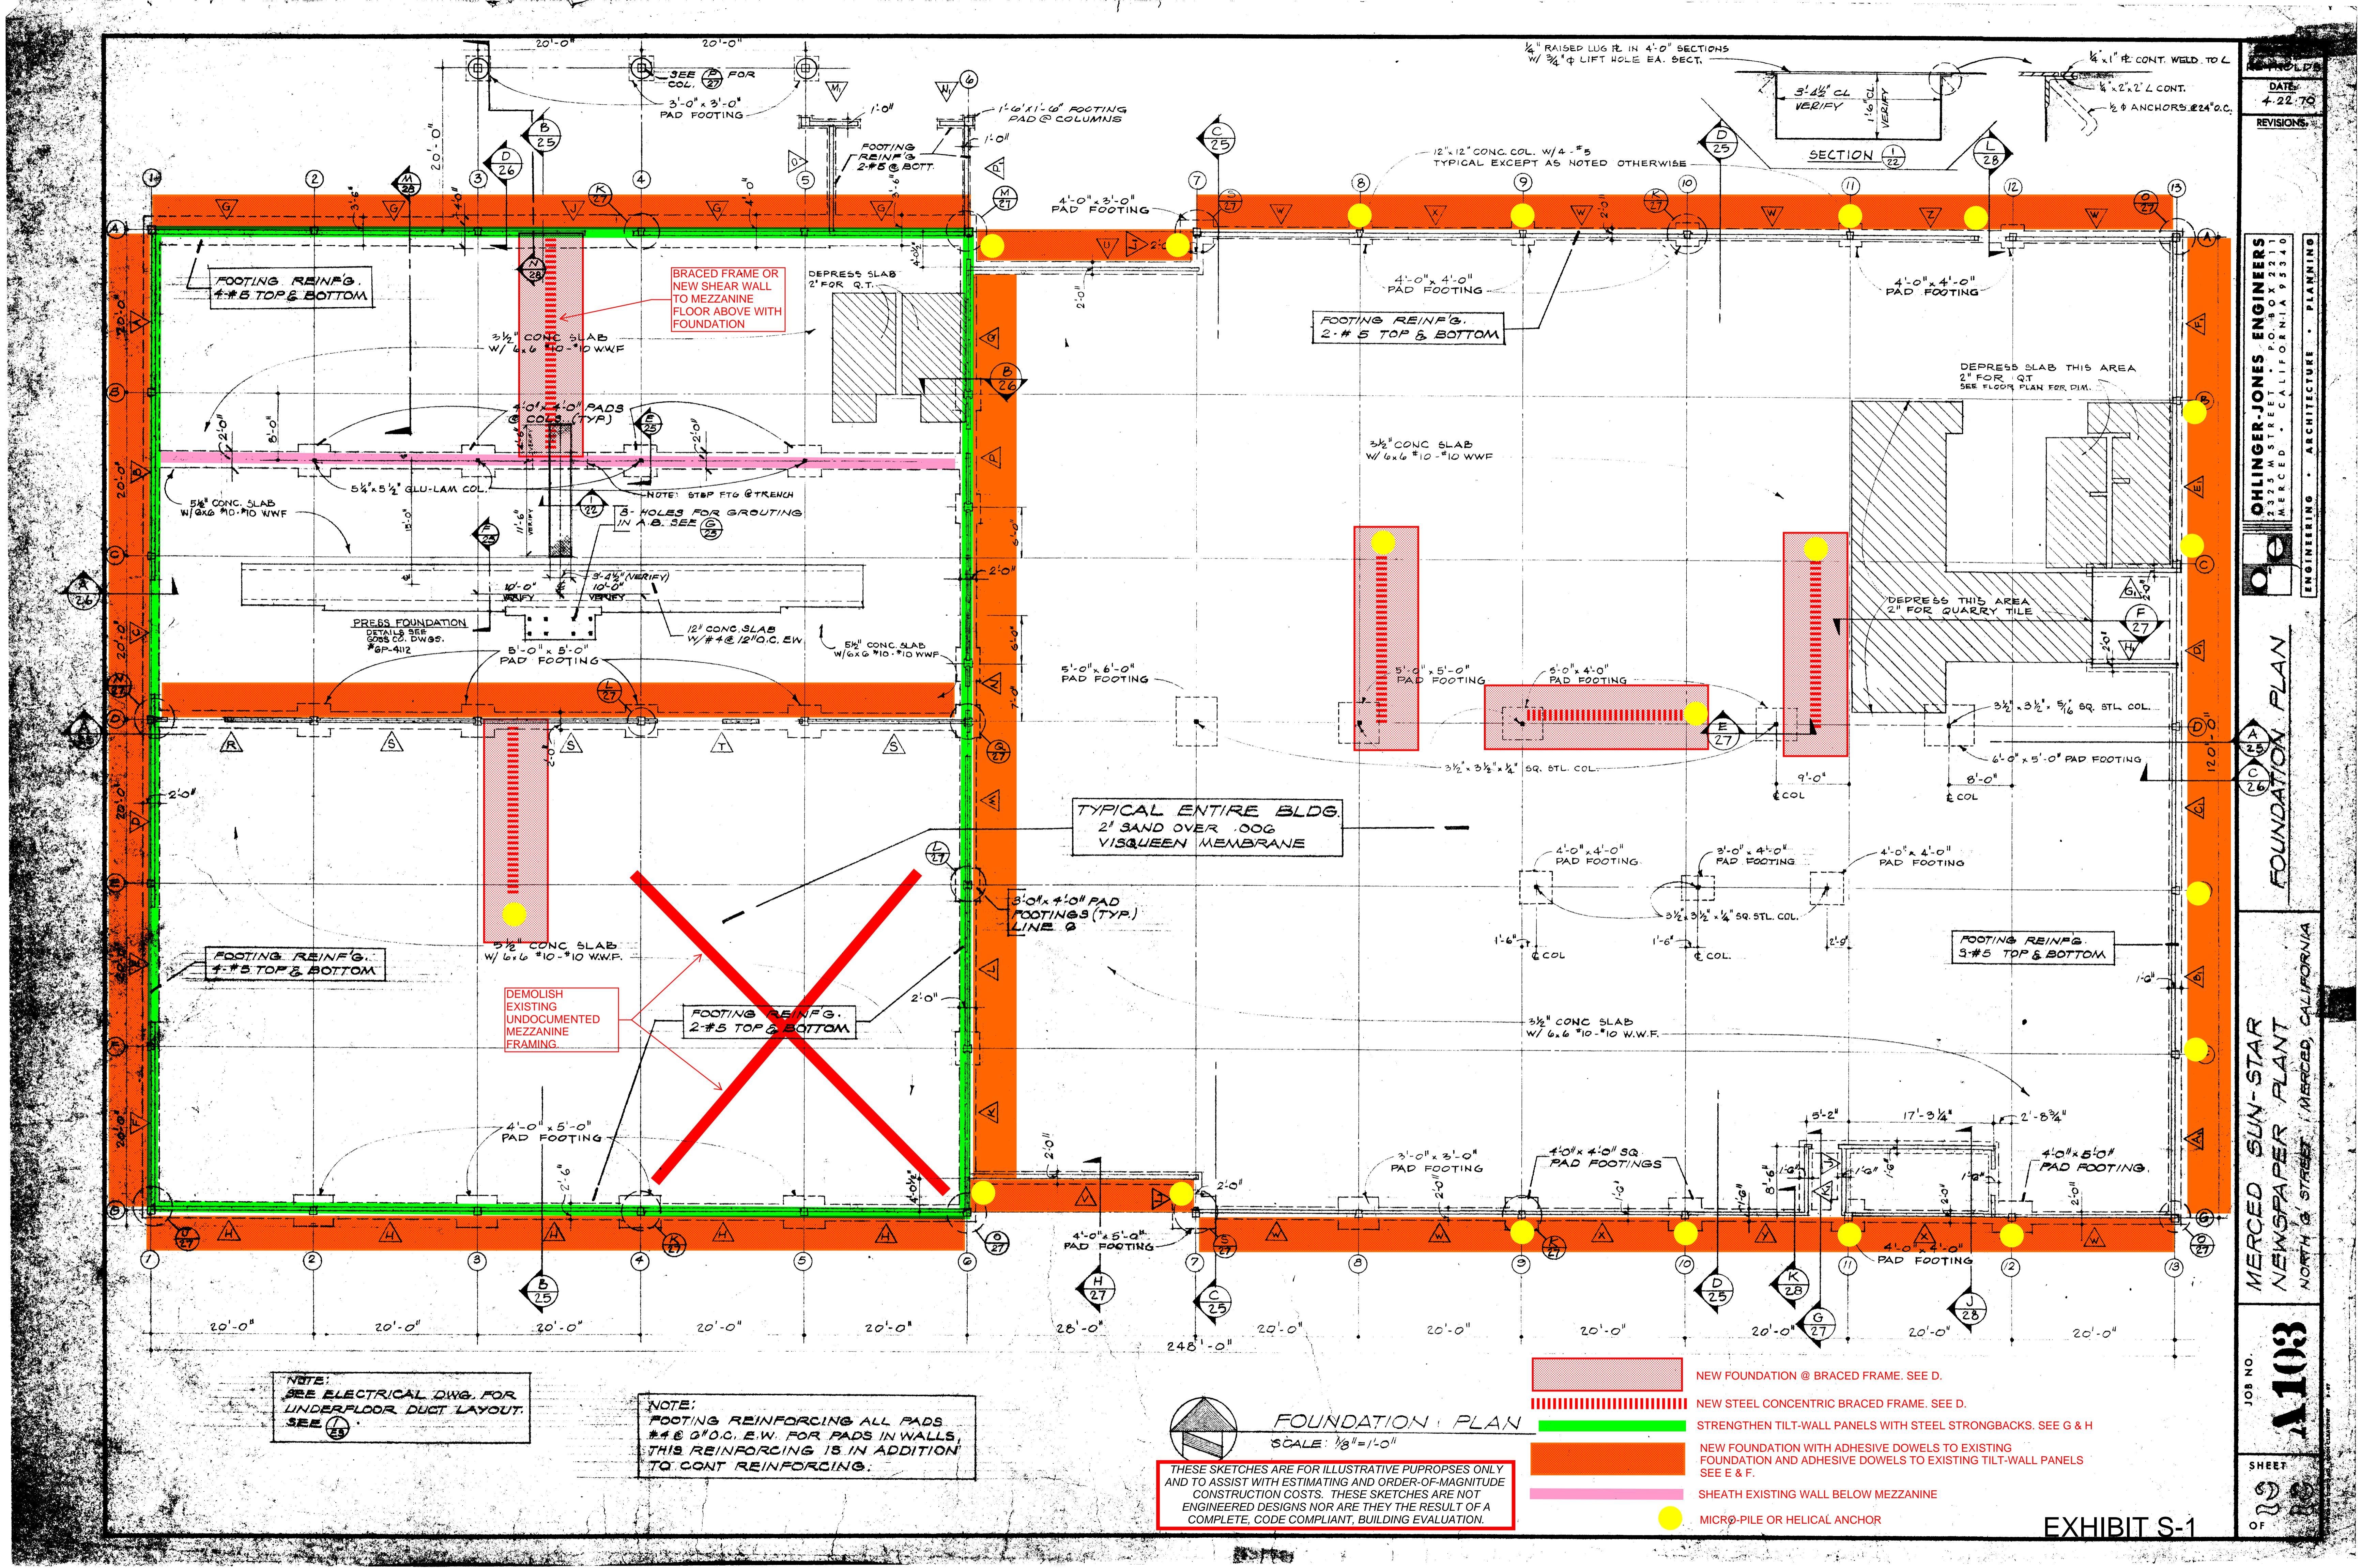
TYPICAL LOW-BAY TILT-WALL FOUNDATION ATTACHMENT & DRAG EXHIBIT S-8

- Tilt walls are not doweled to the foundation to transfer seismic shear. Recommend that new exterior (and interior at Grid D and Grid 6 at the High Bay) grade beams be placed with post-installed reinforcing dowels and pot installed bolts added to structurally connect the tilt-wall panels to the foundation. The grade beam should also be sized to transfer current code seismic loads to the soil.
