City of Merced CA

## Sun Star Building Evaluation

Prepared by  
WMB Architects

February 23, 2016

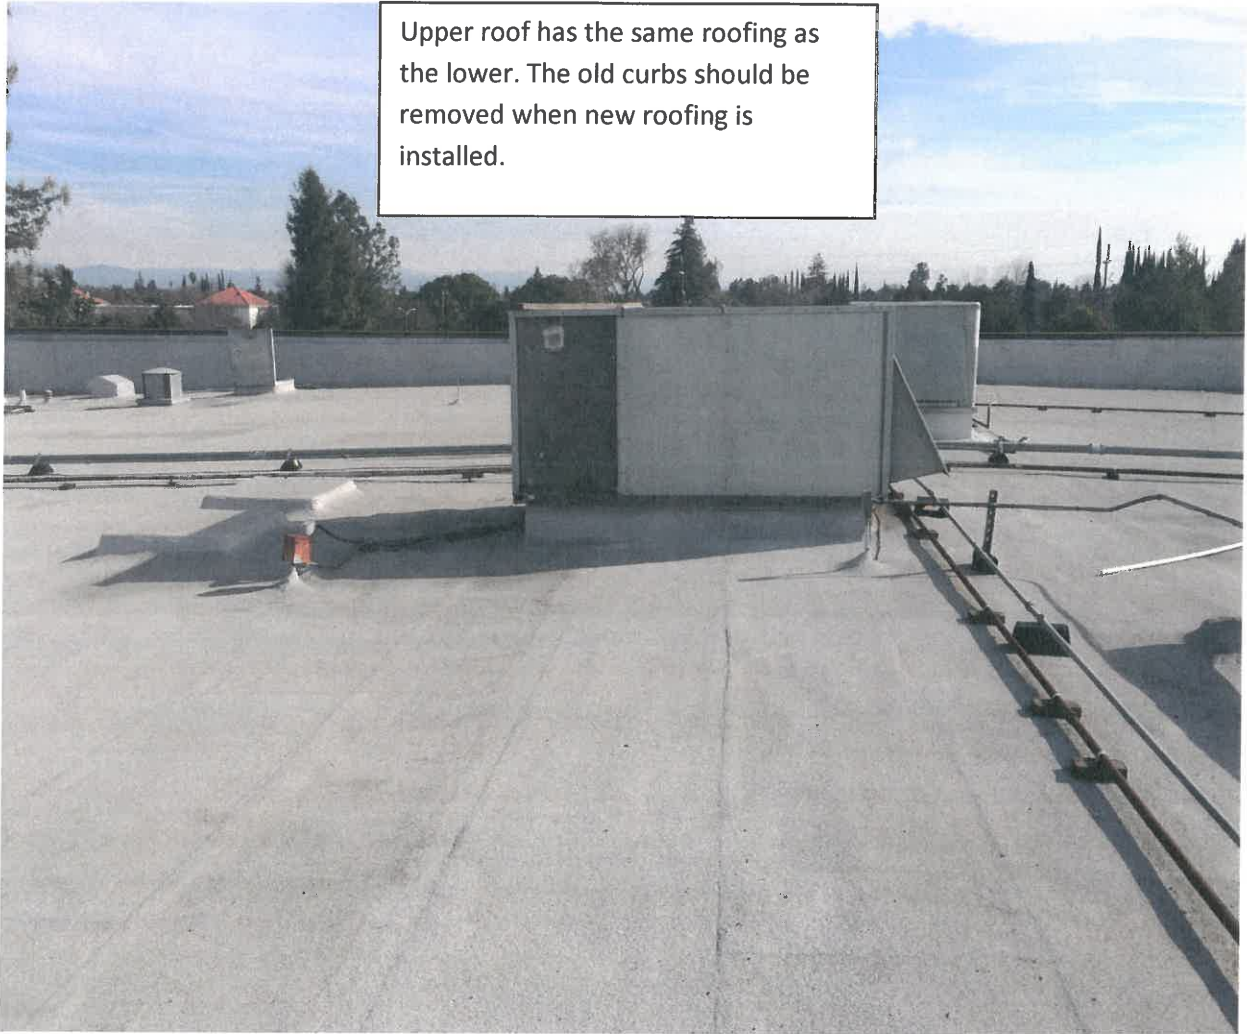
The existing coping is one piece that attaches to the siding. I recommend leaving this in place and using a skirt metal on the inside of the wall.
