City of Merced CA

## Sun Star Building Evaluation

Prepared by  
WMB Architects

February 23, 2016

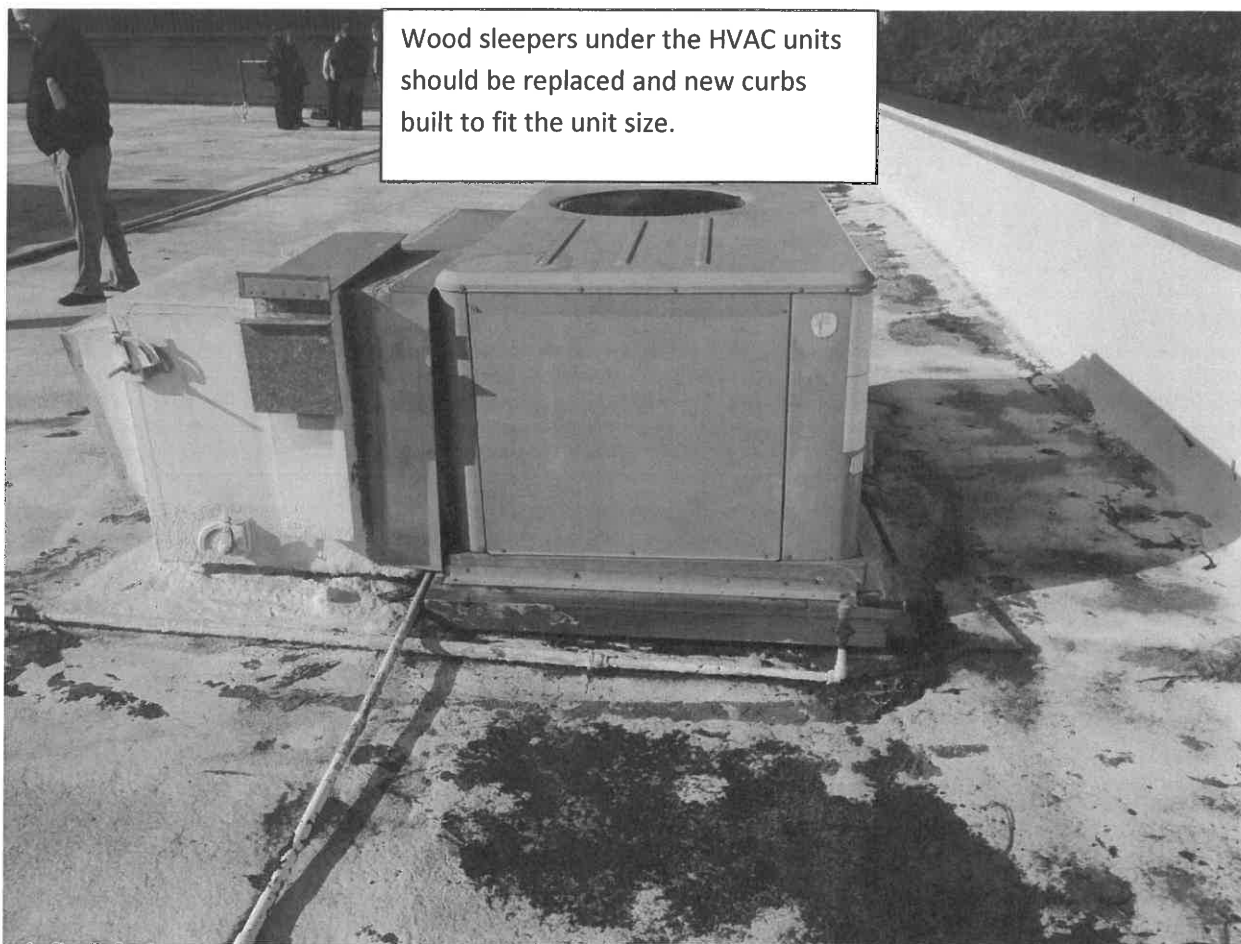
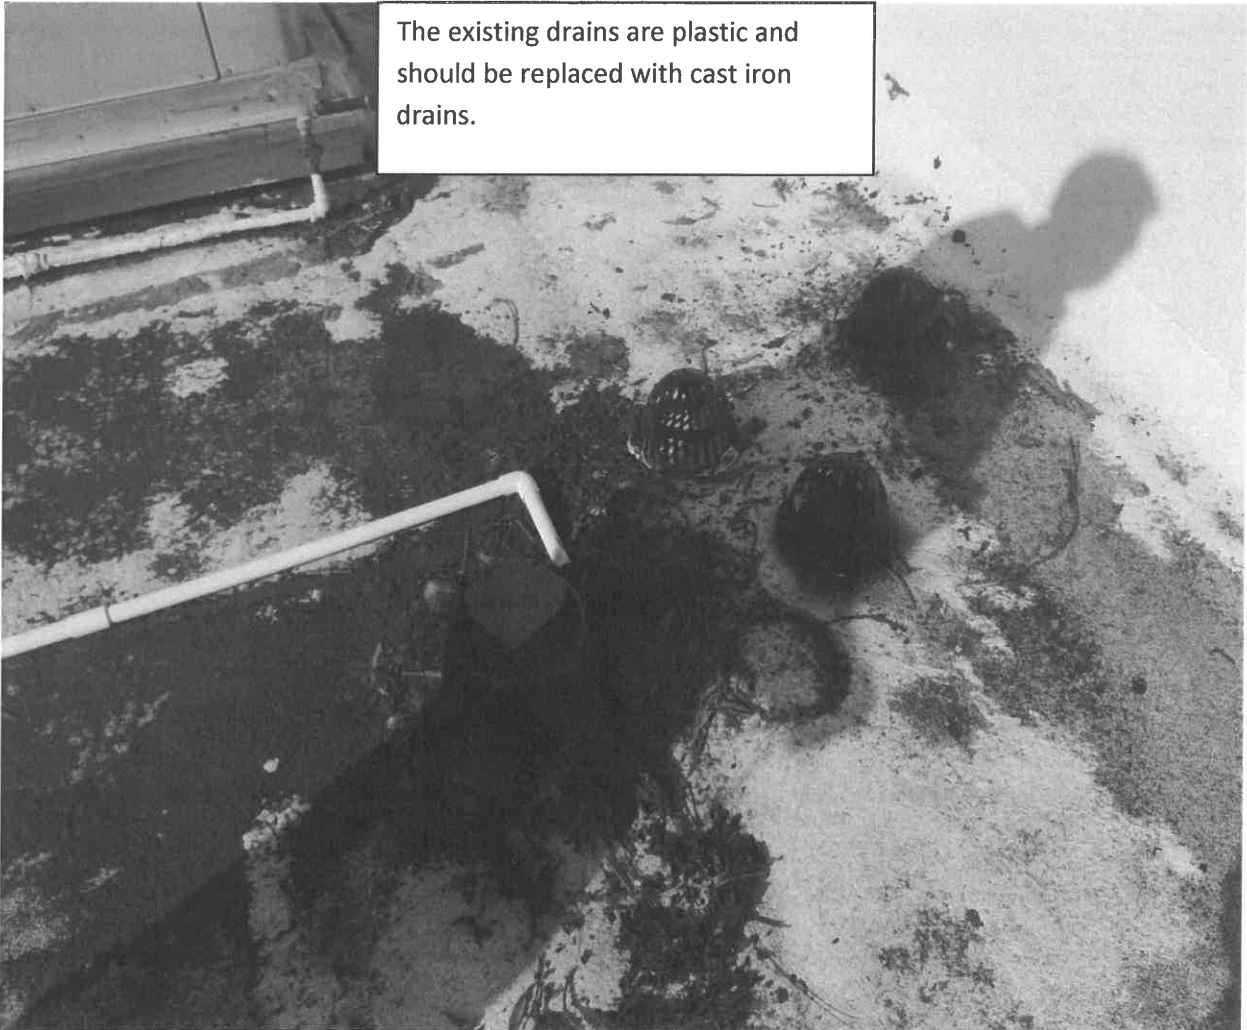
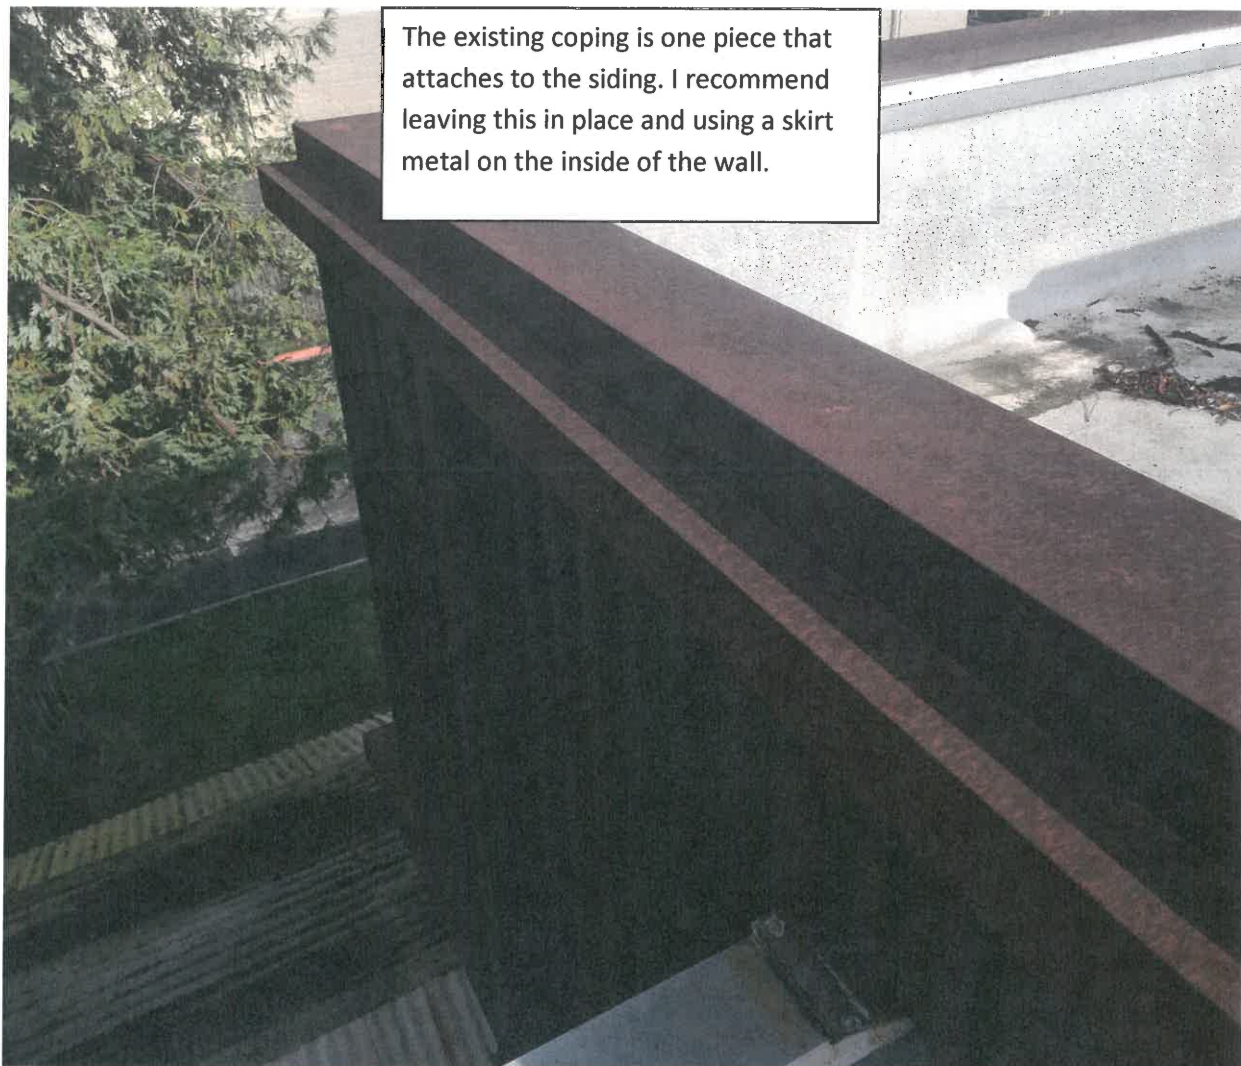
The existing roofing is foam with elastomeric coating over a cap sheet built- up roof over the plywood deck. The foam layer is very thin as the cap sheet lines under it are very visible.

The existing coping is one piece that attaches to the siding. I recommend leaving this in place and using a skirt metal on the inside of the wall.
