# Applegate Park Laura's Fountain Update

## Laura's Fountain

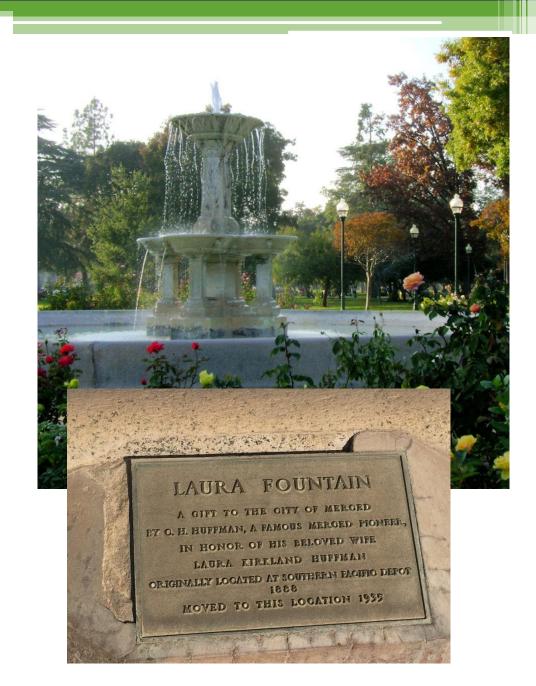
Charles H. Huffman built this marble fountain and granite base in 1888 to honor his wife, Laura Kirkland Huffman. Because of Laura's Fountain, Merced was known as Fountain City to many traveling train passengers. This public fountain was located next to the El Capitan railroad depot that became synonymous with Merced. The fountain was moved to Applegate Park in 1935.

"Merced County Historical Society Archives"
